# GENERAL CIVIL AVIATION INVESTIGATION

## AIR ACCIDENT PRELIMINARY REPORT

BOEING 747-400F/N571 UP  
GCAA ACCIDENT REPORT N° 13/2010

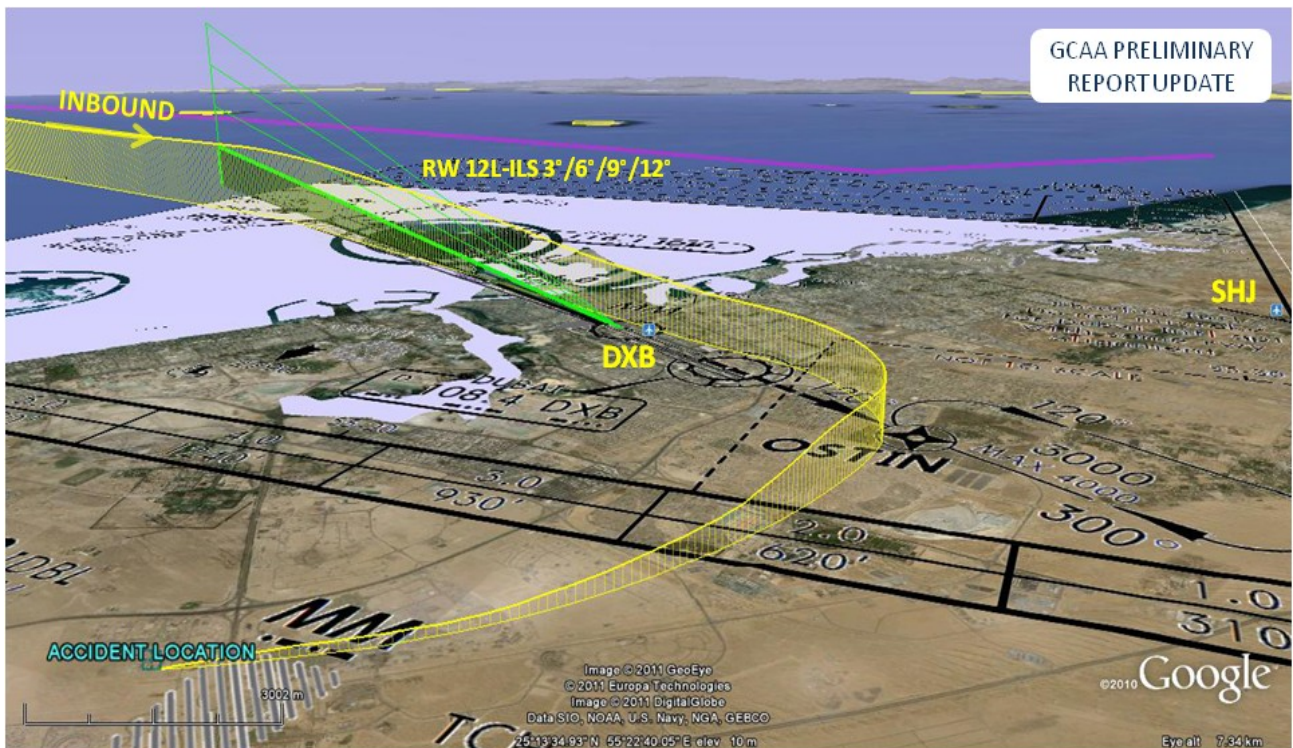
FIG 1. OVER FLIGHT DXB RW12L, RH DESCENDING TURN, ACCIDENT LOCATION

The aircraft crashed 9nm south of DXB on a military installation.

Fig 1 below is an overview of the approach and over flight of DXB , the right hand descending turn and the accident location

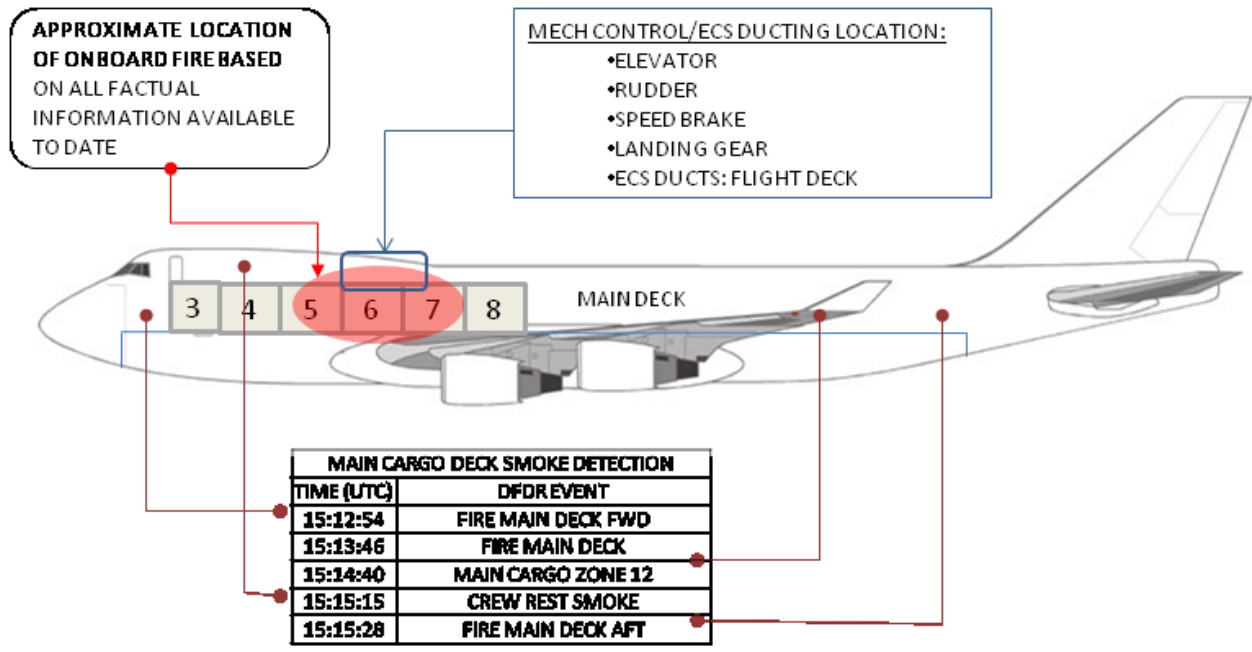
DFDR SMOKE DETECTION/SYSTEMS LOCATIONS

Based on the factual information available, it is possible to determine through the available data, the approximate location of the onboard fire. The first fire alarm is in the forward main cargo compartment zone .

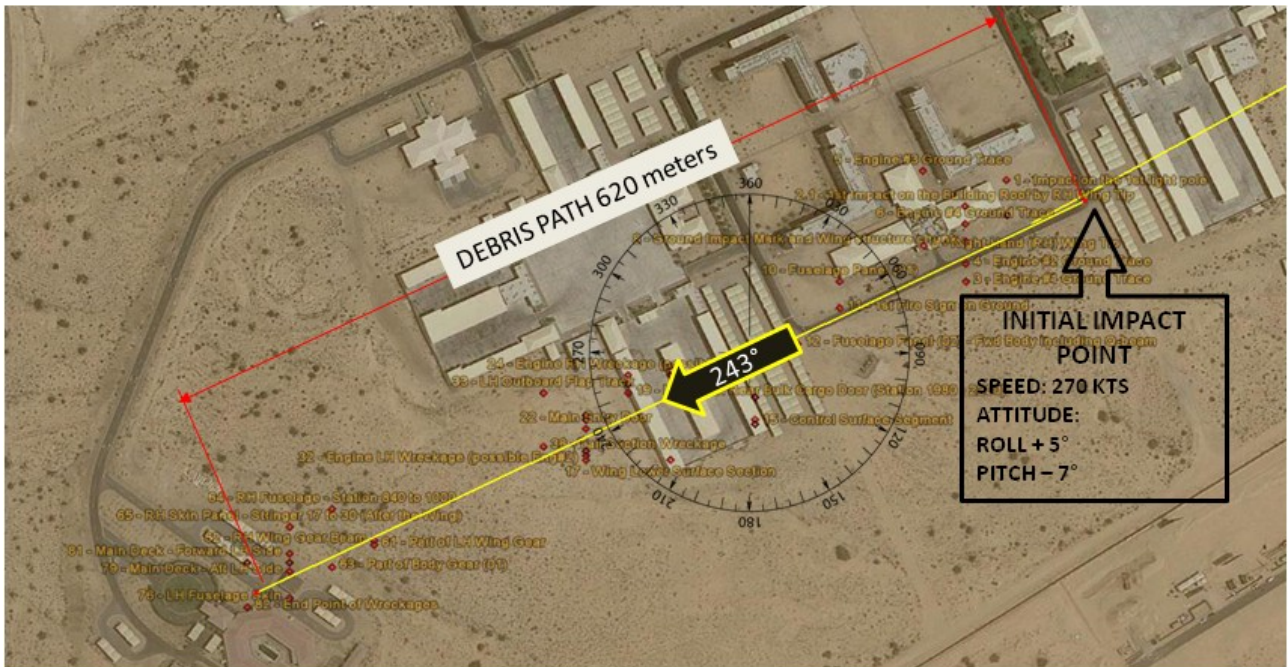
OVERVIEW OF THE ACCIDENT LOCATION

The wings, center and forward fuselage was spread over a 300 meter area, with the cargo, some of the aircraft systems and associated onboard equipment distributed around the debris field.

The majority of the wreckage was damaged in the post accident fire.
