FIRST INTERNATIONAL
SYMPOSIUM ON
VOLCANIC ASH AND
AVIATION SAFETY

**IMPACT OF VOLCANIC ASH FROM REDOUBT
VOLCANO ERUPTION ON GE CF6-80C2
TURBOFAN ENGINES**

**Z.J. Przedpelski, General Electric Aircraft Engines,
Evendale, OH, and T.J. Casadevall, U.S. Geological Survey,
Denver, CO**

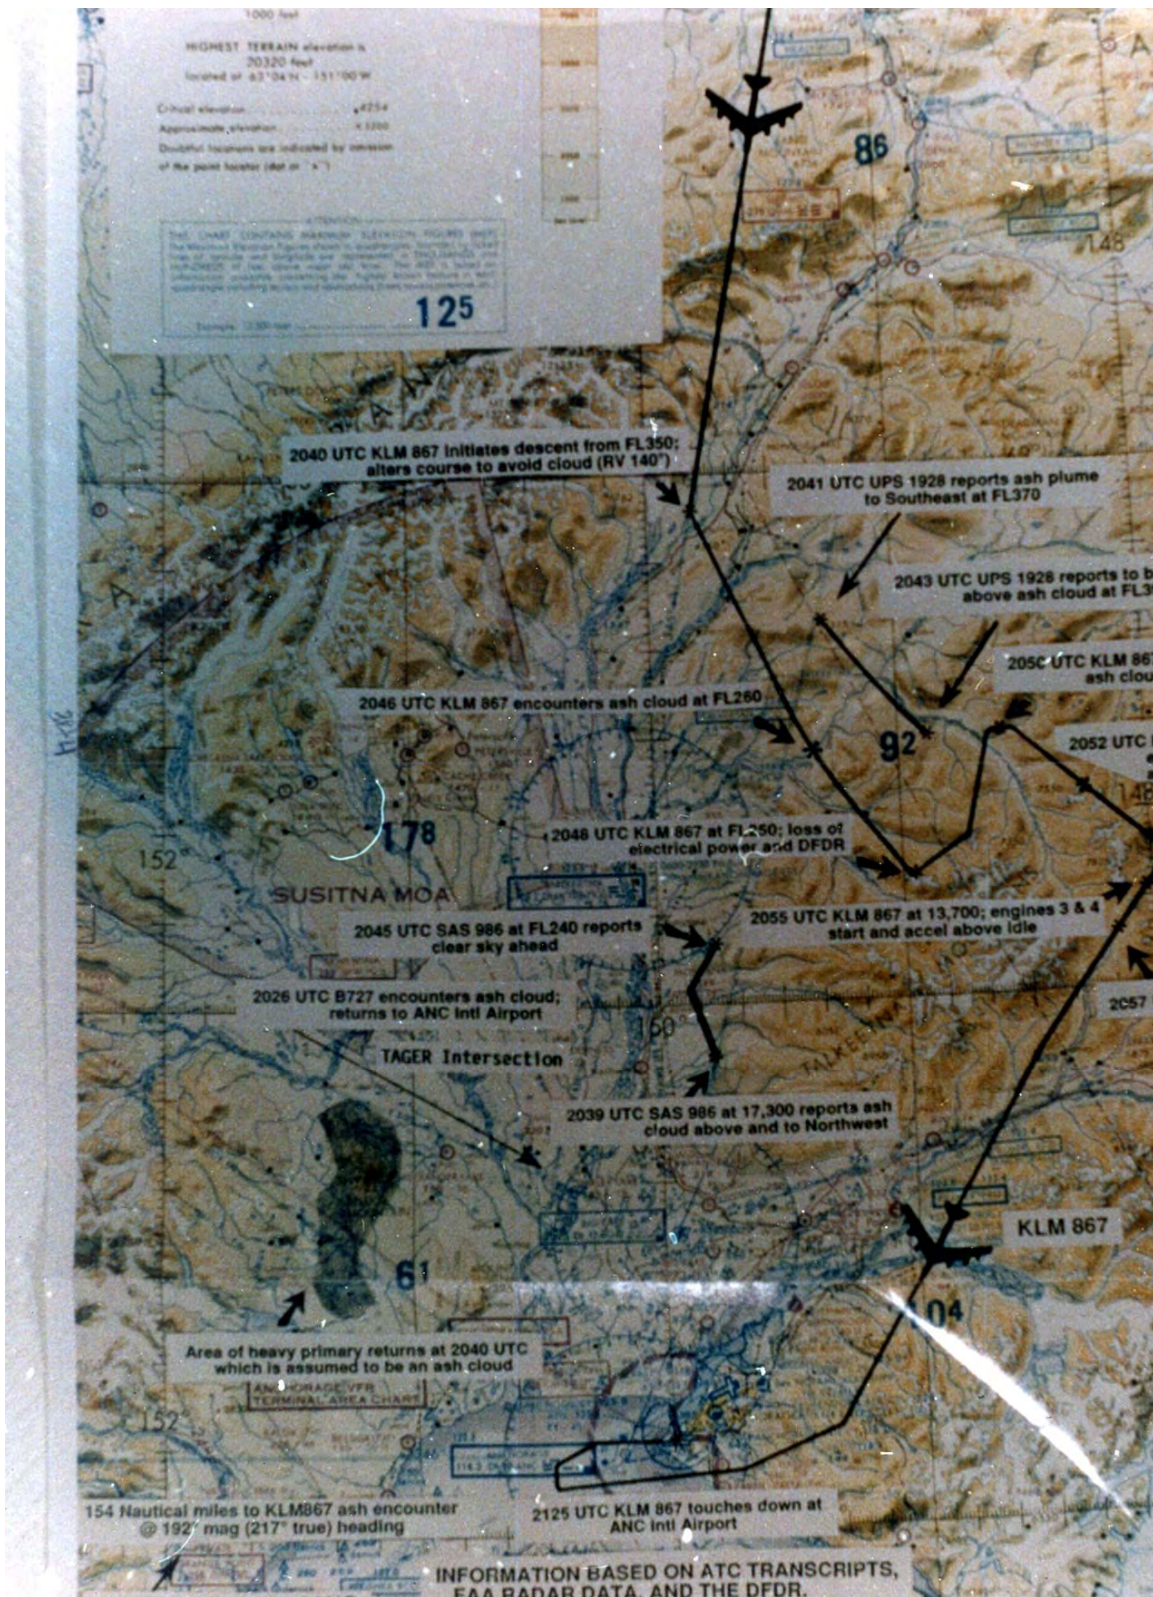
Figure 1 KLM Flight Path

The time sequence of events is shown on the annotated aircraft flight path in Figure 1.

At 1146 A.M. AST, while leveling off at an altitude of 25,000 feet, KLM867 entered a heavy volcanic cloud. Maximum power climb was selected and approximately one minute later all engines decelerated. Engines 1 and 3 decelerated to sub-idle core rotor speed (N2) while engines 2 and 4 settled down at ~80% N2 for approximately 20 seconds before decelerating to sub-idle N2. Aircraft and engine response during that period is shown in Figures 2 and 3.

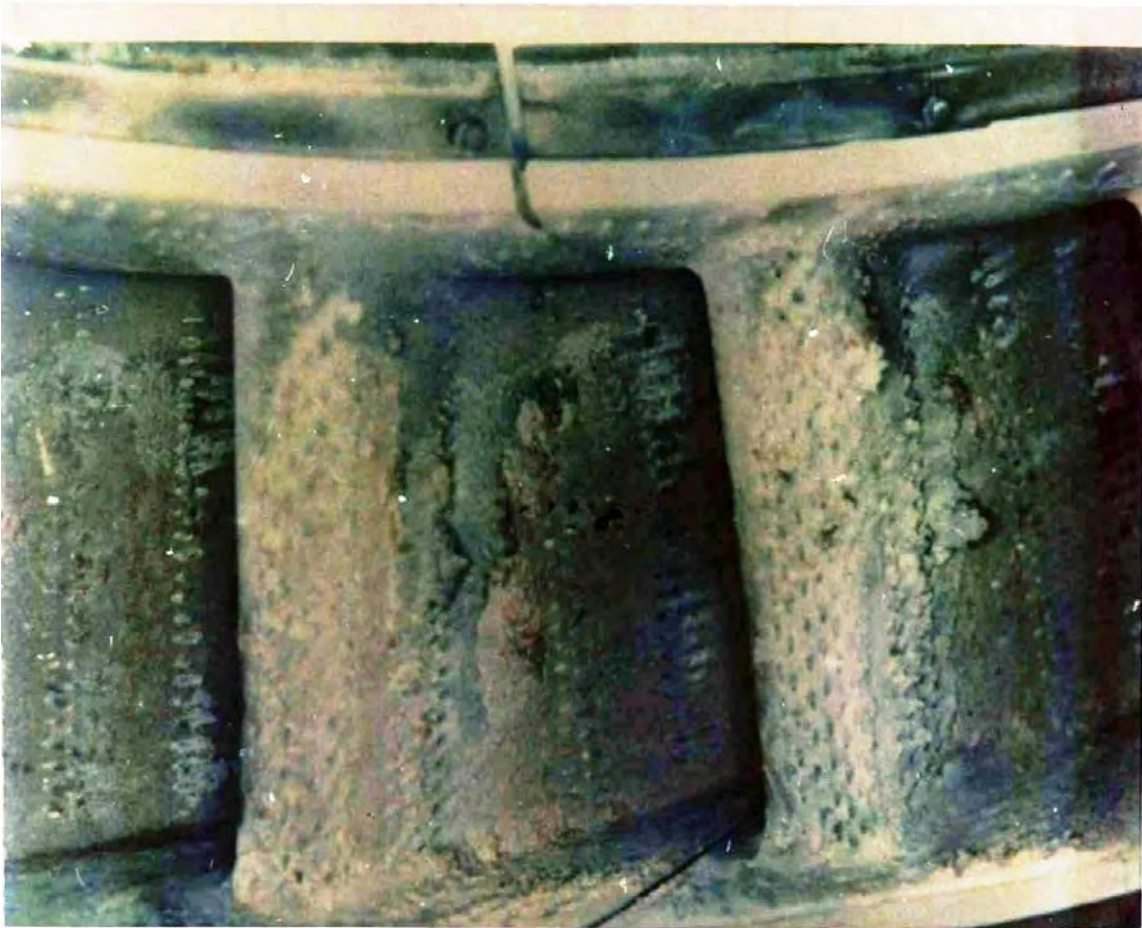
Figure 4

The engines' operation during the high power climb was consistent with rapid reduction of the stage 1 nozzle flow area and associated high pressure turbine (HPT) efficiency reduction. Approximately one half of the maximum deterioration was still present following the successful restarts. Visual inspection of the number 1 engine (ESN 702-131) revealed thick deposits of melted and resolidified ash material on some of the stage 1 NGV's (Figure 4). These deposits were brittle at room temperature and many pieces fell off during the engine transportation and disassembly (Figure 5). The remaining deposits could be easily removed by hand. It was inferred that these deposits built up to maximum just prior to engines' deceleration and gradually became dislodged during the start attempts and during the subsequent engine operation. Based on borescope inspections conducted at Anchorage, approximately 40% of the NGV's were still covered by thick deposits after landing (Figure 6).

The Stage 1 nozzle effective flow area restriction was caused by resolidification and buildup of melted ash particles on the leading edges and on the pressure surfaces of the individual NGV's. This effective flow area restriction was estimated to be 8%. This buildup also resulted in an increase in pressure loss across the nozzle and a reduction in HPT efficiency. Total HPT efficiency loss, including the stage 1 HPT blade clearance increase was estimated to be 7%.

Stage 1 HPT Nozzle Guide Vane Leading Edge Deposit

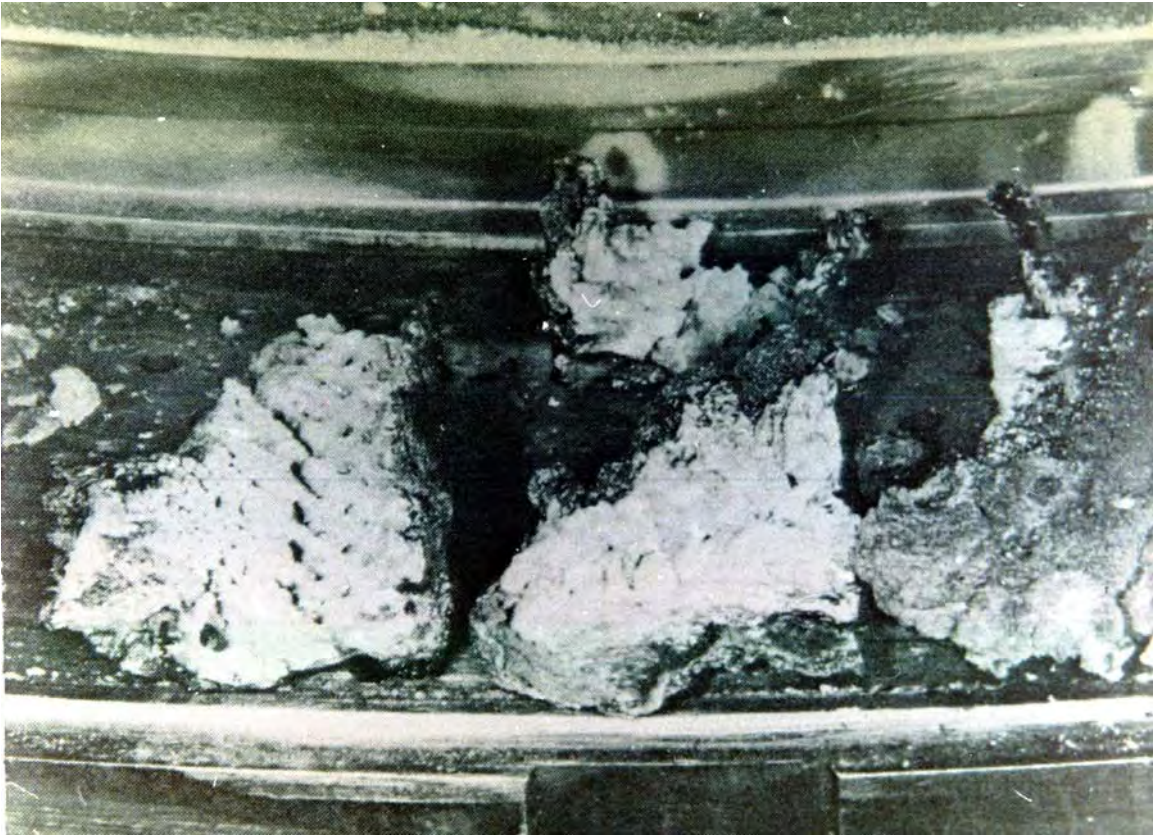
Figure 5

The lowering of the temperature following manual fuel supply cut-off increased the viscosity and brittleness of the built up material. The thermal and pressure/velocity transients associated with the fuel off/on/off cycle dislodged some of the nozzle deposits. The density of these deposits was low and consequently there was no downstream airfoil damage. Successful starts were achieved after a portion of these deposits were dislodged.

**Stage 1 Nozzle Guide Vane Leading Edge Deposits
Disclosed During Disassembly**

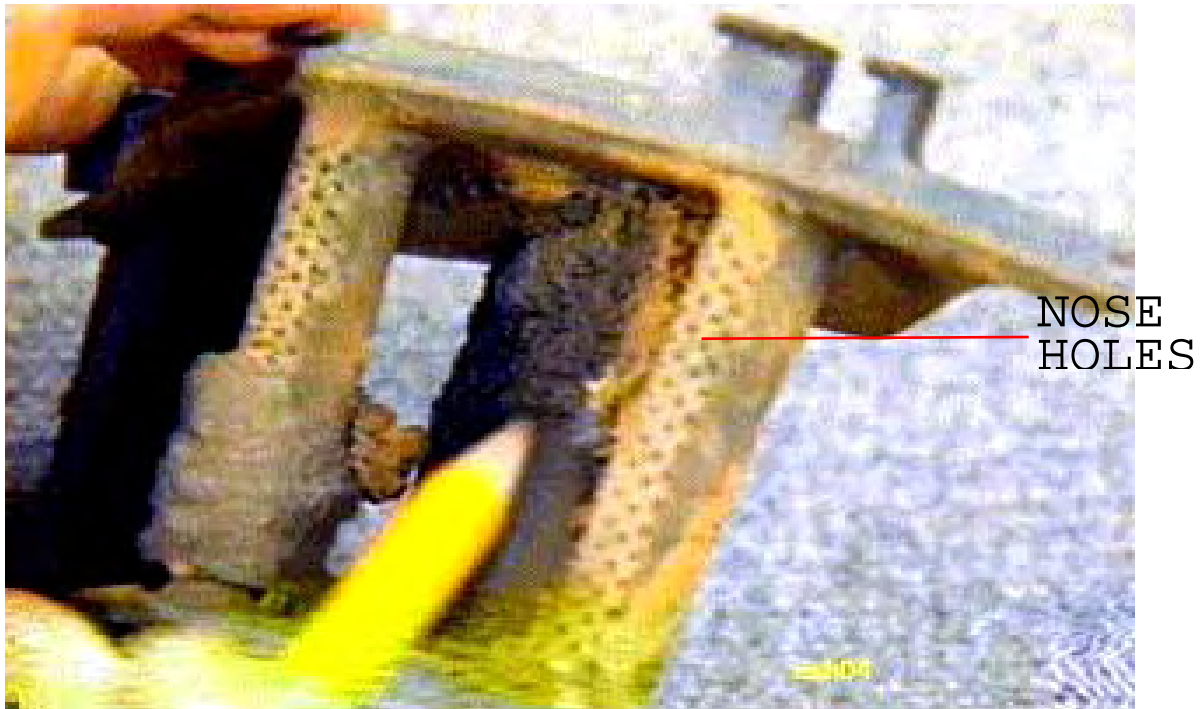
Figure 6

**Sketch of the Stage 1 HPT Nozzle Based on Inspection of
Engine No. 1**

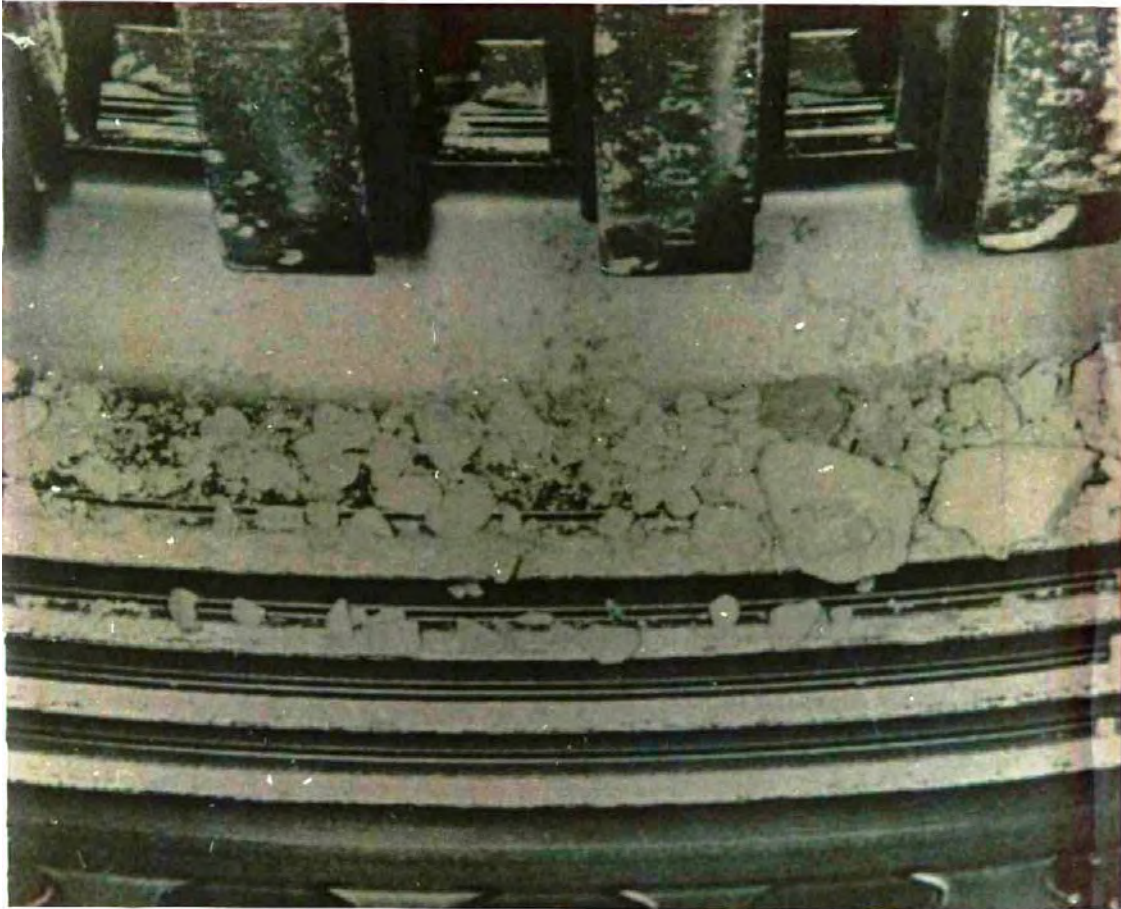
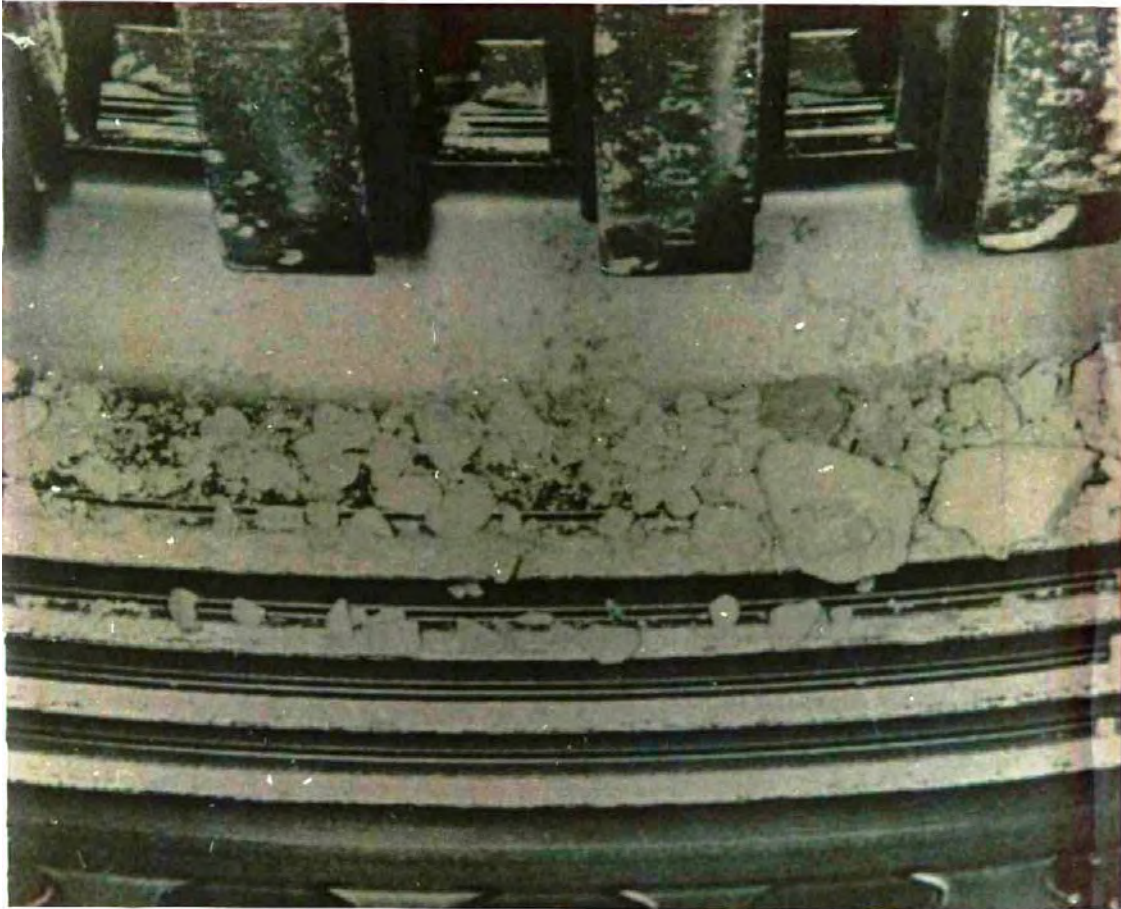
Figure 7
Accumulation of Ash in the HPT Rotor

Engine No. 1 inspection indicated that there was no significant plugging of any of the HPT cooling circuits; however, there was a heavy fine powdery ash buildup within the HPT rotor cavities (Figure 7).

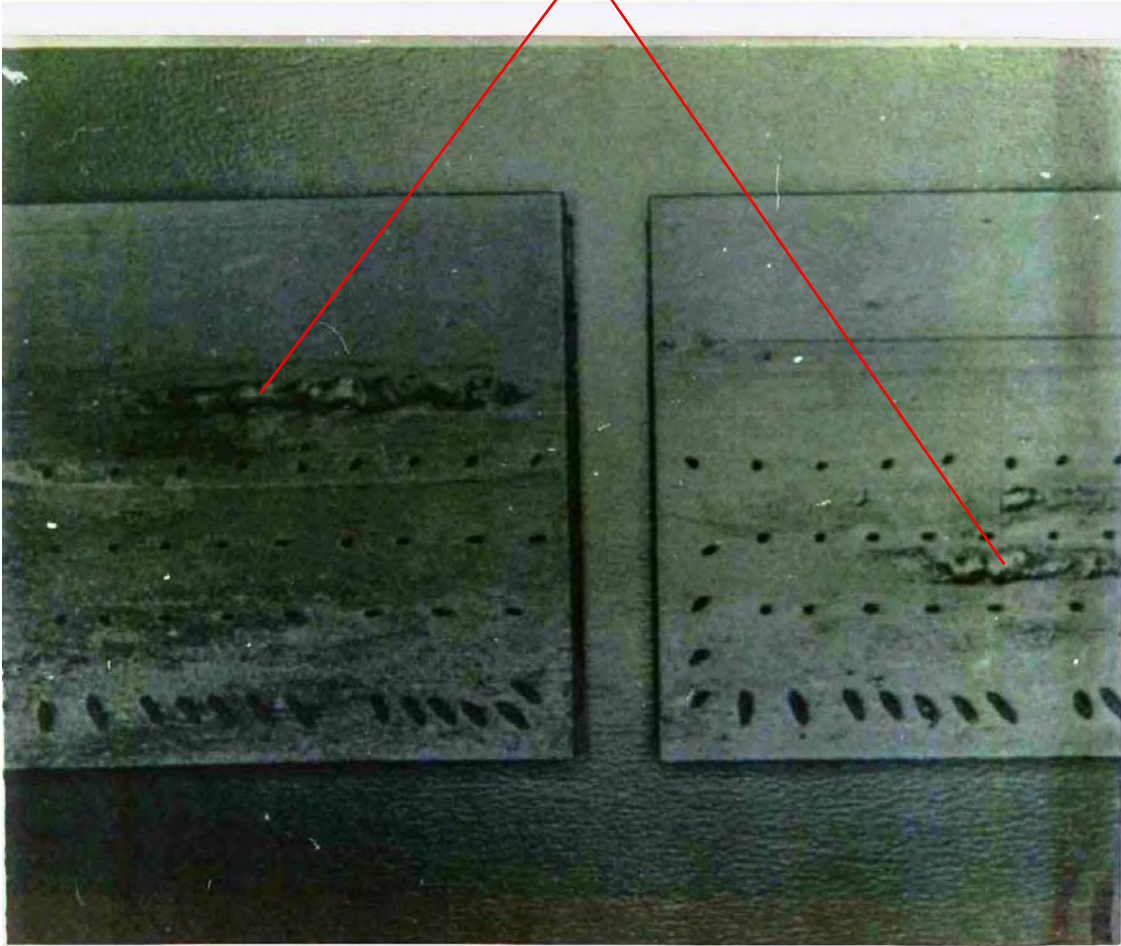
The Stage 1 HPT bucket clearance increase was caused by local hard buildup of melted/resolidified ash material on the shroud surface (Figure 8) which grinded off the bucket tip material.

Figure 8
Hard Ash Material Deposit on Stage 1 HPT Shrouds

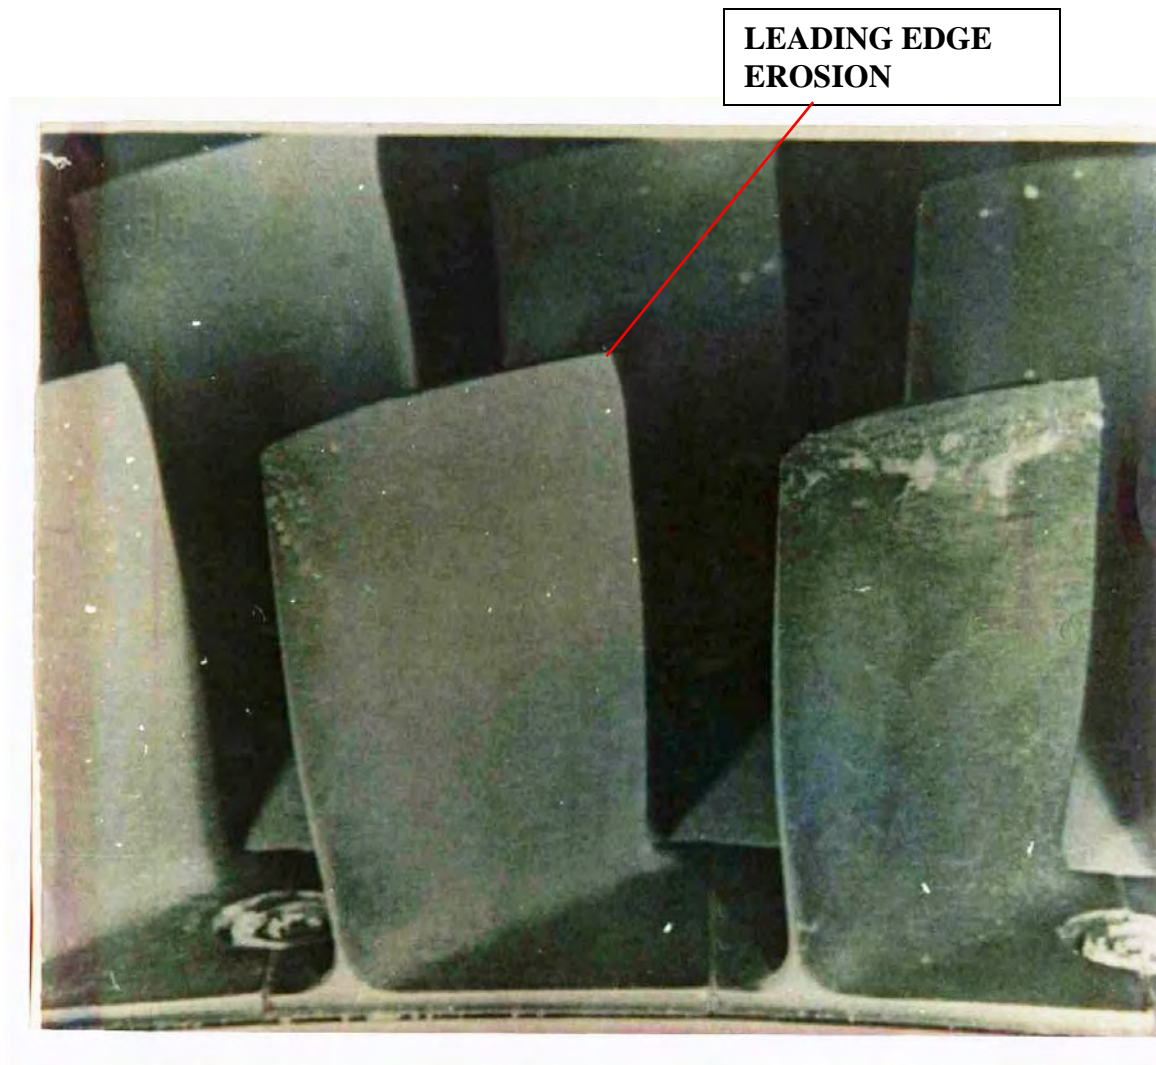
High Pressure Compressor (HPC) erosion (Figure 9) caused by ingestion of the ash particles resulted in minor stall margin decrease and compressor efficiency loss estimated to be 1%.

Figure 9
HPC Blades Leading Edge and Tip Erosion
