In accordance with the Board's rules, the Air Line Pilots Association submits the following comments concerning the accident involving Comair Airlines Flight 5054, which occurred on March 19, 2001 near West Palm Beach, Florida.

**SUBMISSION OF THE
AIR LINE PILOTS ASSOCIATION
TO THE
NATIONAL TRANSPORTATION SAFETY BOARD
REGARDING THE ACCIDENT INVOLVING
Comair Flight 5054
OFF WEST PALM BEACH, FLORIDA
ON MARCH 19, 2001**

ALPA Submission on Comair Flight 5054, EMB-120
West Palm Beach, Florida, March 19, 2001

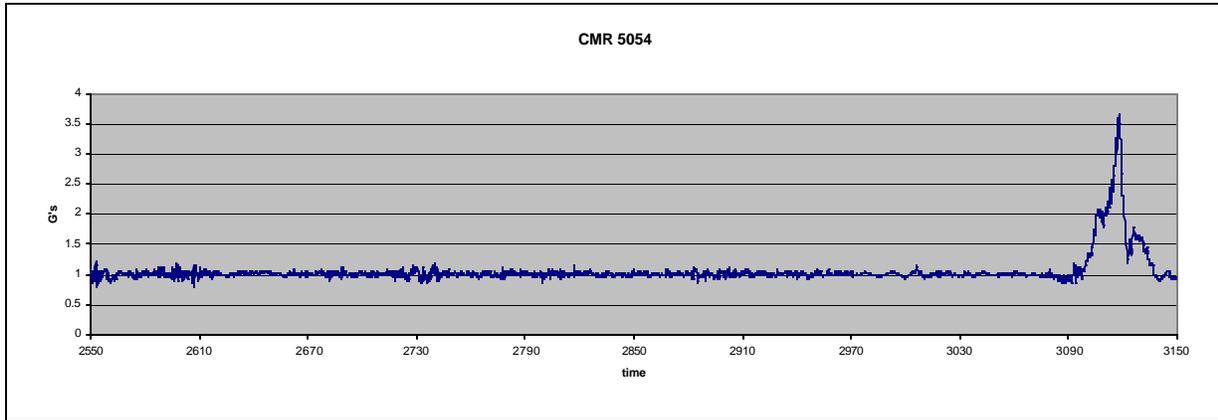
Figure 3

The factual report for the Operational Factors Group contained a “Summary of EMB-120 Simulator Demonstration.” The simulator was run with similar environmental conditions (airspeed, altitude, etc.) and then heavy icing was introduced. The factual report states: “It took about four minutes for the simulator to slow from 180 knots to 140 knots . . . as the airspeed was slowing from 180 knots to 140 knots, rudder input could be felt as the airspeed changed and the pitch change was significant and noticeable to the pilot. The pitch change was evident on the horizon indicator and was felt by the pilot.” It should be noted that this simulator was only a simple reenactment, and not able to truly re-create the environmental conditions experienced during the actual event. The actual flight was experiencing substantial turbulence at the time that the trim was being entered, over the last few minutes, as shown in the vertical G FDR shown in Figure 3. This would have severely degraded the ability of the crew to detect the change in pitch attitude and the airspeed degradation.

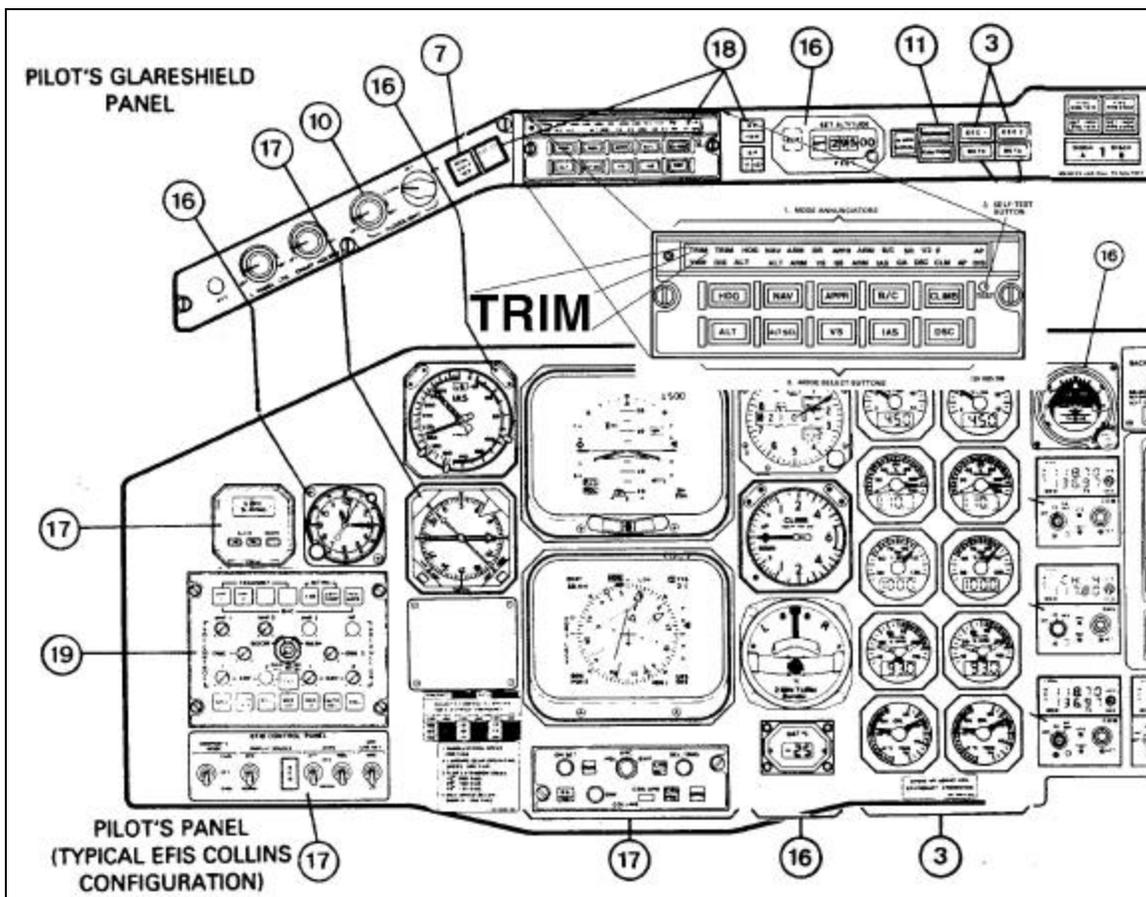
Figure 4 shows that the annunciator light provided for elevator trim in motion is not an adequate alerting indicator unless the crew already has their attention focused on this panel. The “TRIM” annunciator is in white, and illuminates to indicate that the trim system is in motion.

The airplane was on autopilot, which trimmed the elevator trim tab in order to attempt to maintain the selected flight level cruising altitude. The crew did not notice the trim in motion due to their attention being focused on other activities in the cockpit and environmental influences that overshadowed the effect of the trim on airplane attitude and airspeed. The trim reached a high value of nose up trim which caused the airplane to be very difficult to control upon the autopilot being disengaged.

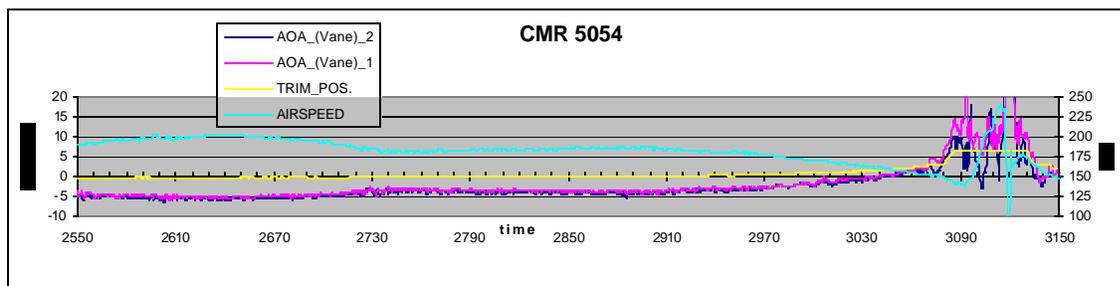
The graph in Figure 5 clearly shows that the AOA reached just 10 degrees as the trim reached a limit. Similarly, the Performance Group factual report documents the degradation in the lift coefficient to under 10% of the nominal lift coefficient (as a function of AOA), as the angle of attack (AOA) increases past 5°.

The airplane experienced icing conditions that caused the autopilot to automatically trim the elevator in an Aircraft Nose Up direction, increasing the Angle of Attack. The wing stalled as the Angle of Attack was increased. The stall warning system did not engage at an Angle of Attack low enough to provide a reasonable margin of safety to prevent the wing from stalling.

5. The manufacturer should modify the logic in the stall warning system for the EMB-120 to decrement the angle of attack at which the stall warning system activates the stick pusher so that the airplane cannot approach the stalled condition when in icing environmental conditions.

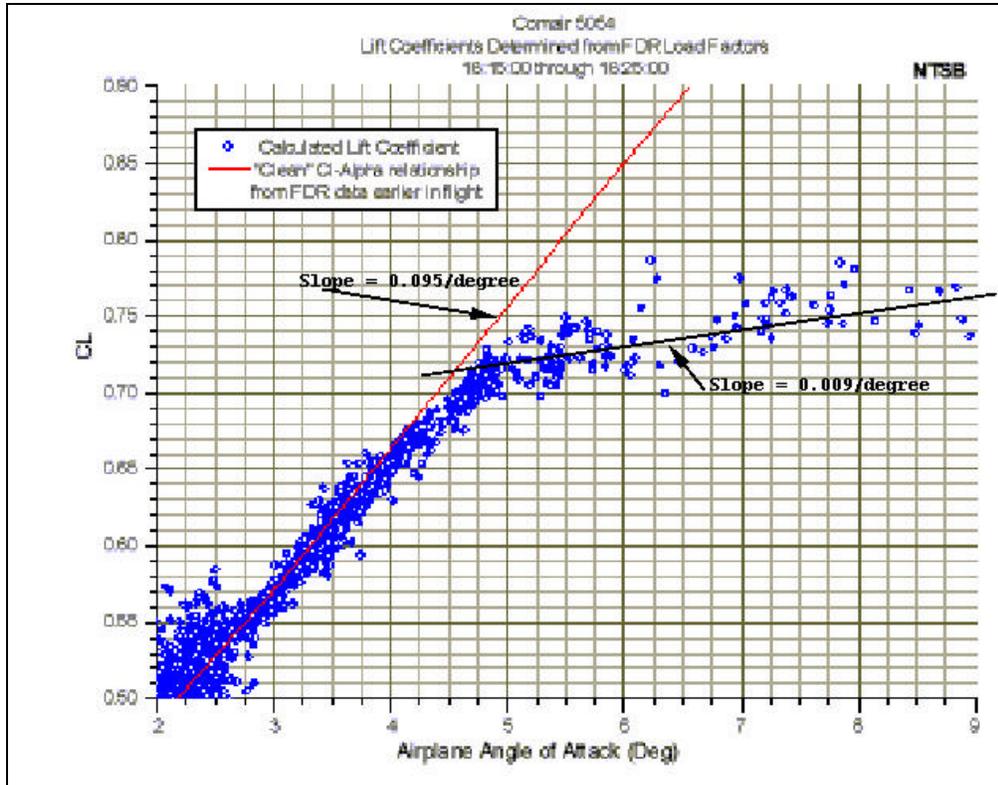
The factual report of the Performance Group contains graphs that clearly show the lift coefficient degrades with ice accretion (see figure 3 of the Performance Group Factual Report, Figure 6 below). This graph shows that the lift coefficient for the uncontaminated wing had a regular relationship increasing as the angle of attack increased, however for the contaminated wing, based on the actual flight data, the lift coefficient increased proportional to the AOA at only 9.5% of the rate of increase experienced below 5° AOA.

This degradation of the lift coefficient resulted in a significantly degraded aircraft performance. Such a characteristic resulted in the airplane rapidly losing speed as the autopilot trimmed the elevator trim tab in an attempt to achieve a higher lift coefficient in order to maintain altitude.

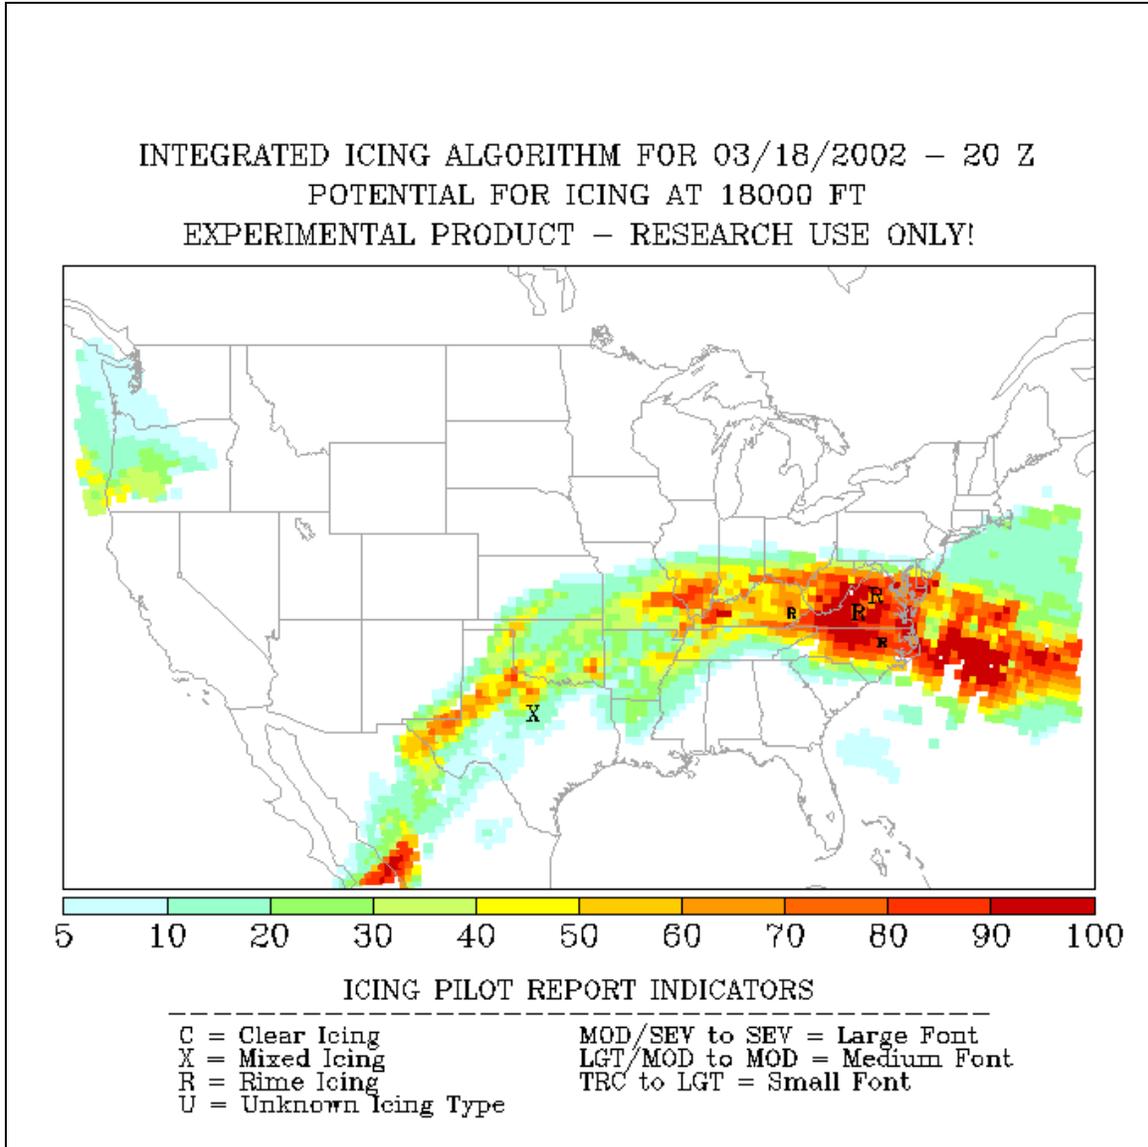
Figure 7

Table 3 shows that none of the accidents or incidents on record occurred in subtropic regions. Yet the prior flight leg showed icing and the following chart from an advanced icing research facility showed icing in southern regions, though by coincidence, not as far south as the subject accident.

8. Further research and development is needed regarding forecasting and prediction of icing in subtropical regions.
9. Systems and methods should be developed to enhance a crew's ability to detect and avoid icing conditions that exceed the demonstrated capability of the airplane.
10. Flight crews should be provided real time weather charts with detailed icing information included.
