AIR LINE PILOTS ASSOCIATION, INTERNATIONAL

Reference: Air Midwest Flight 5481, DCA03MA022

**SUBMISSION OF THE
AIR LINE PILOTS ASSOCIATION
TO THE
NATIONAL TRANSPORTATION SAFETY BOARD
REGARDING THE ACCIDENT INVOLVING
AIR MIDWEST FLIGHT 5481
IN CHARLOTTE, NORTH CAROLINA
ON JANUARY 8, 2003**

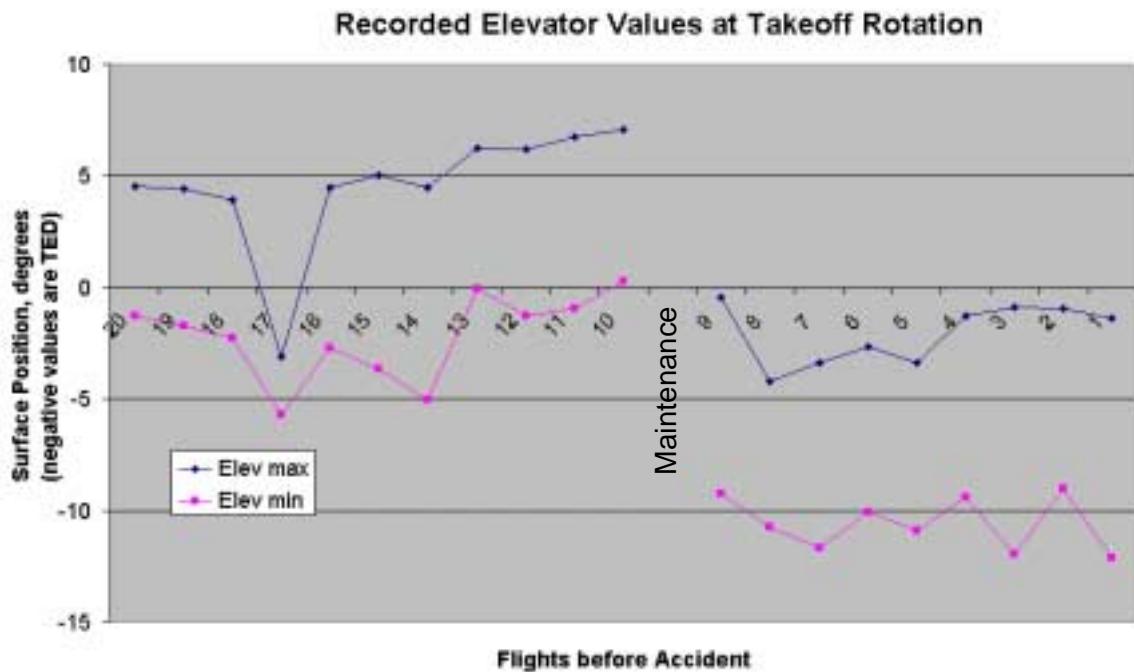
Based on the facts known about the maintenance activities, and the basic aerodynamic principle that there is a defined range of elevator positions for an aircraft to rotate on takeoff or to fly trimmed for cruise flight, the offset observed on the DFDR data can only be explained by the misrigging scenario.

Figure 1 shows elevator inputs for takeoff rotation for 20 flights. The upper lines represent the maximum TEU elevator during the takeoff rotation, and the lower lines represent the maximum TED elevator to arrest the rotation. The values of the maximum TEU and TED are relatively constant for the flights before the maintenance, relatively constant for the flights after maintenance, but differ significantly between the pre- and post-maintenance flights. Throughout all the flights, however, the *differences* between these TEU and TED maximums are approximately the same. None of the crews on any of the flights reported flight control anomalies, so it is reasonable to conclude that all the takeoff maneuvers were normal, and thus nearly identical. Figure 2 presents the cruise phase elevator and elevator trim values for the same 20 flights. The relatively constant trim values indicate that the actual elevator position was also relatively constant. However, the recorded elevator position exhibits the same large discontinuity (offset) between pre- and post-maintenance flights. The offsets between the pre- and post-maintenance flight data in both these figures can only be explained by the misriggering scenario.
