Re: Executive Airlines (d.b.a. American Eagle) flight 5401
Accident Number: DCA04MA045
San Juan, Puerto Rico

**SUBMISSION OF THE
AIR LINE PILOTS ASSOCIATION
TO THE
NATIONAL TRANSPORTATION SAFETY BOARD
REGARDING THE ACCIDENT INVOLVING
Executive Airlines (d.b.a. American Eagle) Flight 5401
At San Juan, Puerto Rico
ON MAY 9, 2004**

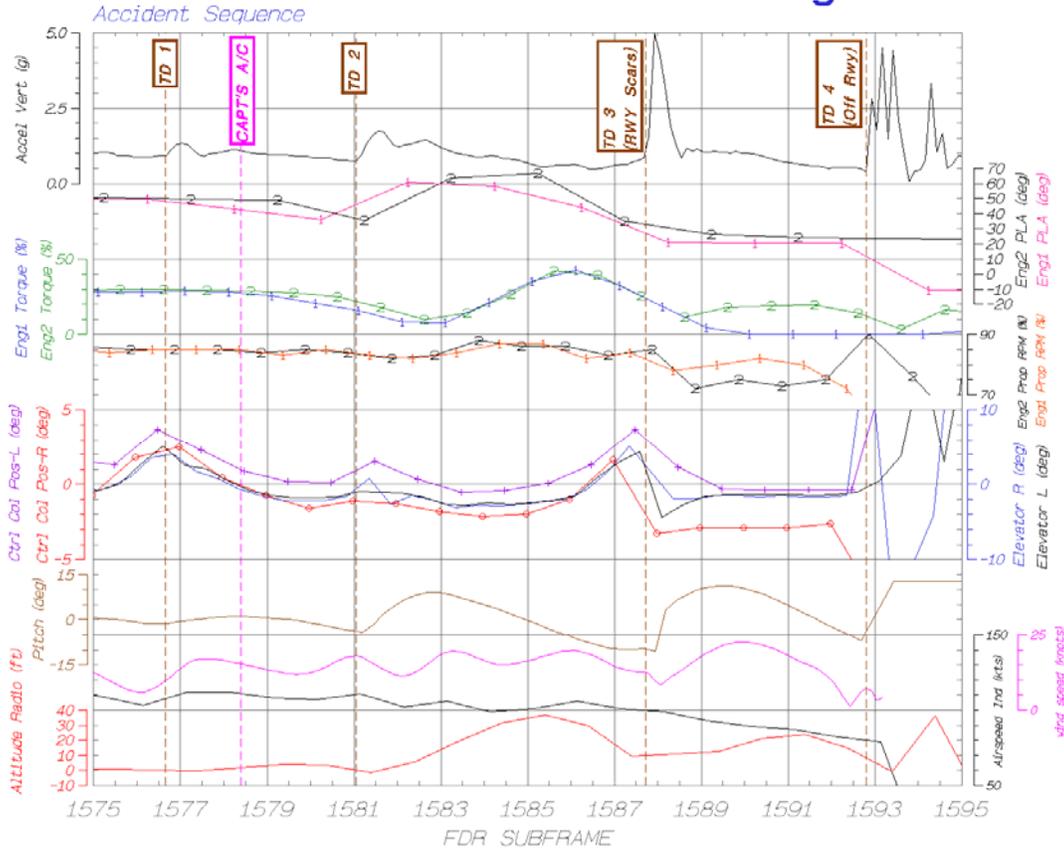
The data used to generate Figure 1 is data supplied by the NTSB FDR and Aircraft Performance Groups. The following paragraphs describe the significant events during the accident sequence, and the items in single quotes refer to the text boxes seen in figure 1. As noted above, initially the F/O was the PF.

1. First Bounce ('TD 1'):

As the F/O attempted the landing the wind speed decreased suddenly by 7 knots and as he attempted to arrest the resultant sink rate the wind increased back another 10 knots, which resulted in a touchdown and bounce at approximately 1576 seconds DFDR subframe time as indicated in Figure 1 (i.e. 1173 ET¹ + 403² also equal to 18:49:39³). According to interviews

2. Captain takes the aircraft ('CAPT'S A/C'):

At approximately 1578, just a fraction over one second after the first bounce, the captain took control of the aircraft⁵. One second later (two seconds after the first bounce) the power is reduced as can be seen by the DFDR Engine Power Lever Angle (PLA) data showing a movement from approximately 50° to 35°, just 5° over the flight idle position. This indicates an initial attempt by the captain to land the airplane.

3. Second Bounce ('TD 2'):

The captain's power reduction was combined with increasing the pitch attitude in an attempt to flare, but was counteracted by the wind gust. Therefore, at approximately 1581 the aircraft bounced a second time. This touchdown resulted in 1.7 vertical g's, which is insufficient to cause any aircraft damage. The 11 knot gust that began just before the first bounce continued and peaked for a total 20 knots wind velocity. This extra 11 knots contributed to the aircraft becoming airborne again rather than remaining on the ground.

4. 9° Nose Up Pitch Attitude:

After the second bounce the pitch rapidly increases to 9° ANU (airplane nose up) pitch attitude at approximately 1582.5. The captain applied a small ANU control column movement that started just prior to the second bounce that primarily reduced the AND (airplane nose down) pitch attitude command. The elevators remained in an AND position except for a brief moment and then immediately returned to its previous position of about 2° AND. The aircraft's pitch attitude increased to 9° nose up during a time when the captain commanded a less nose down pitch attitude, not a nose up pitch attitude.

5. 11° Nose Down Pitch Attitude:

Between the second and third bounces the aircraft ended up in an 11° nose down pitch down attitude at approximately 1587 due to the combination of a loss of wind and the captain's power reduction. The captain attempted to counter the quick descent with aft movement of the control column (approximately 4°), which is approximately one third of the total control column movement available. However, the backpressure was not sufficient due to the loss of wind, which the captain had no way of knowing about. The aircraft's performance at this point was confusing to the captain⁶. This is reasonable, particularly because just a small amount of backpressure (approximately 1.5°) at the second bounce was followed by the aircraft pitching up to 9° and climbing to 37 feet, yet three times that amount of backpressure at this point didn't even slow the descent sufficiently to prevent a hard impact. ALPA believes that any pilot would have had a concern at this point to not over control the aircraft and bounce again. Therefore, there was likely some apprehension to increase the aft control column movement even more or faster than was done.

6. 3rd Bounce ('TD 3 (RWY Scars)'):

At about 1588 the aircraft impacts the ground very hard (5 vertical g's) and bounces back into the air for the 3rd time. This third impact resulted in the Left Main Landing Gear (LMG) breaking off from the aircraft, as evidenced by the scars that were left on the runway. In addition, the nose gear collapsed aft into the fuselage. This likely caused significant damage to the flight and engine control linkages, and rendered the aircraft uncontrollable.

7. 4th Touchdown ('TD 4 (Off Rwy)'):

After the third touchdown which rendered the aircraft partially or completely uncontrollable, the crew was essentially 'along for the ride' until the aircraft came to rest. Due to the flight and engine control linkage damage that occurred at the third touchdown, the DFDR data after the third bounce provides no insight to the cause(s) of the accident.

In summary, the 12 knot wind gust occurring during the first two bounces between 1576 - 1581 countered the captain's power reduction and resulted in the aircraft becoming airborne again. The loss of 8 knots wind occurring between 1586 – 1587.5 compounded the effect of the power reduction leading up to the third bounce at approximately 1588. The timing of these wind fluctuations made the aircraft unpredictable and were the primary contributors to the accident.

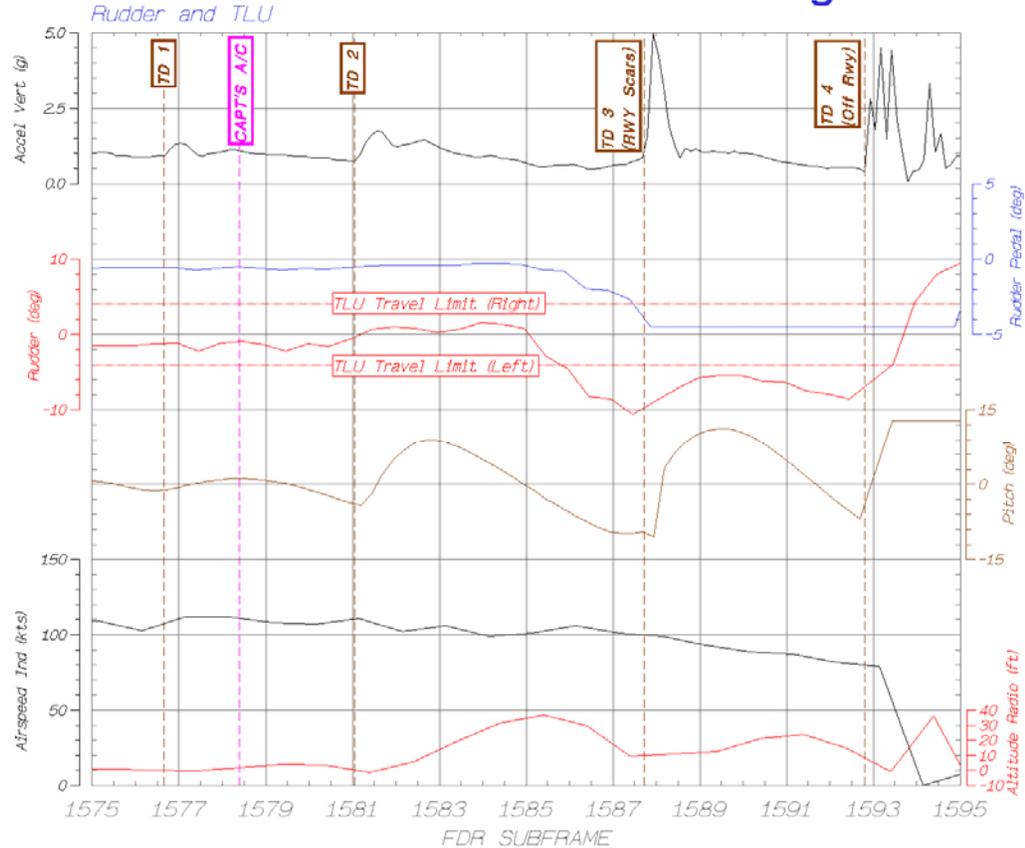
During the accident investigation the TLU switch was found in the HI speed position. However, as can be seen in Figure 2 below, the Rudder reaches greater than a 10° deflection at 1587.5. This 10° deflection occurs prior to any impact that could have damaged the aircraft and exceeds the $\pm 4^{\circ}$ limits imposed when the TLU is set to HI-speed. Therefore, the TLU could not have been set to HI-speed during the approach and must have ended up in this position sometime later in the accident sequence or after the accident, such as during evacuation.
