Reference: Northwest Airlines Flight 74, **DCA05MA095**

SUBMISSION OF THE  
AIR LINE PILOTS ASSOCIATION  
TO THE  
NATIONAL TRANSPORTATION SAFETY BOARD  
REGARDING THE ACCIDENT INVOLVING

Northwest Airlines Flight 74

August 19, 2005

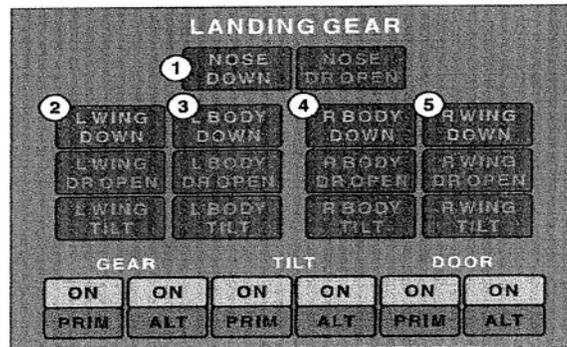
in an incorrect position it might be annunciated in a variety of ways, but typically with an amber or red light. In the Boeing 747-200, the landing gear portion of the Flight Engineer Panel does not follow this typical human factors logic. To ensure that the gear is down, the Flight Engineer must verify that there are five green lights. If there are not five, the unlocked gear will not be red, but will be dark. The specific issue with the nose gear is that all the main gear lights are in a straight-line on the panel and the nose gear is above that offset to the left.

Therefore if the nose gear is not extended, the Flight Engineer may observe only the four green lights and assume that all the gear are extended. Increasing the likelihood of this type of event occurring is the fact that as part of his normal preflight, the Flight Engineer checks the Tilt of the main gear and is looking for four lights. The other design factor that may have prevented this accident was the gear indications on the forward panel. On most transport category aircraft there is a green light for each set of gear on the forward instrument panel, near the landing gear lever. In this case if there had been five lights on the forward panel, it may have alerted the crew to the possibility that the nose gear was indeed not in the down and locked position.

With regards to the accident flight, based on the statements specifically from the Second Officer, it appears as though he felt that he saw the number of lights he was supposed to see. The Cockpit Voice Recording indicates that at 1407:27, the Captain asks the Second Officer “what do you have for the gear lights?” Six seconds later at 1407:33, the Second Officer states “four here.” The remainder of the recording the Captain and Second Officer both state that all the gear is down, but never verbalize another number.
