# I. EXECUTIVE SUMMARY

## A. History Of Flight

At 0607 Eastern Daylight Time (EDT) on August 27, 2006, a Canadair RJ (CL65-2B19), N431CA, operated by Comair Airlines (CMR) Flight 5191, crashed on takeoff from Bluegrass Airport, Lexington, Kentucky (LEX). The flight was destined for Atlanta, Georgia. There were 3 crew members and 47 passengers on board. Forty nine of the 50 souls onboard received fatal injuries and one received serious injuries.

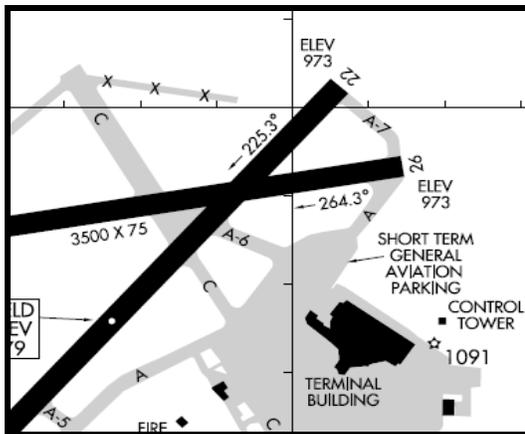
Figure 1- AFD portrayal

The preceding events resulted in several charting and signage discrepancies following the repaving during the weekend of August 20, 2006. The AFD presented an accurate representation of the airport, except north of runway 26 (see Figure 1). In this area the AFD depicted a single “A7” taxiway leading to the runway 22 threshold. In actuality, there were two taxiways north of runway 26; neither of which were “A7”. When sitting on taxiway “A” at the hold short line south of runway 26, the view was as follows: Directly across runway 26 was the closed portion of taxiway “A”. At approximately a 70 degree angle to the left across runway 26 was the re-designated taxiway “A”. This was the taxi route leading to runway 22.

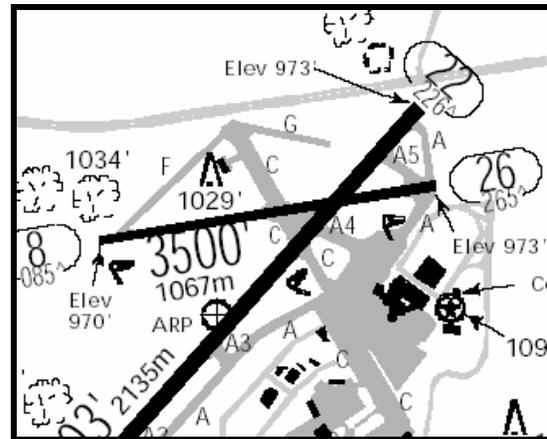
Figure 2: Jeppesen Portrayal

The Jeppesen airport diagram (10-9 chart) presented an accurate representation of only two taxiways along Comair 5191’s taxi route (see Figure 2): Taxiway “C” slightly to the south while exiting the air carrier ramp, and taxiway “A” up to the runway 26 hold short line. Three taxiways were depicted inaccurately. First, taxiway “A4” south of runway 26 was signed as “A6”; Second, taxiway “A5” was depicted as north of runway 26 and was signed as taxiway “A”; and Third, taxiway “A” north of runway 26 was depicted but was actually barricaded closed. On the Jeppesen chart, which the crew had, taxiway “A” north of runway 26 was depicted as an operational taxiway leading to runway 22.

The Jeppesen chart also did not incorporate 2 NOTAMs in effect since 2001. One designating runway 8-26 as unusable for landing or taxiing of aircraft over 12,000 lbs GWT (gross weight) and the other designating runway 8-26 as daytime VMC (visual meteorological conditions) use only.

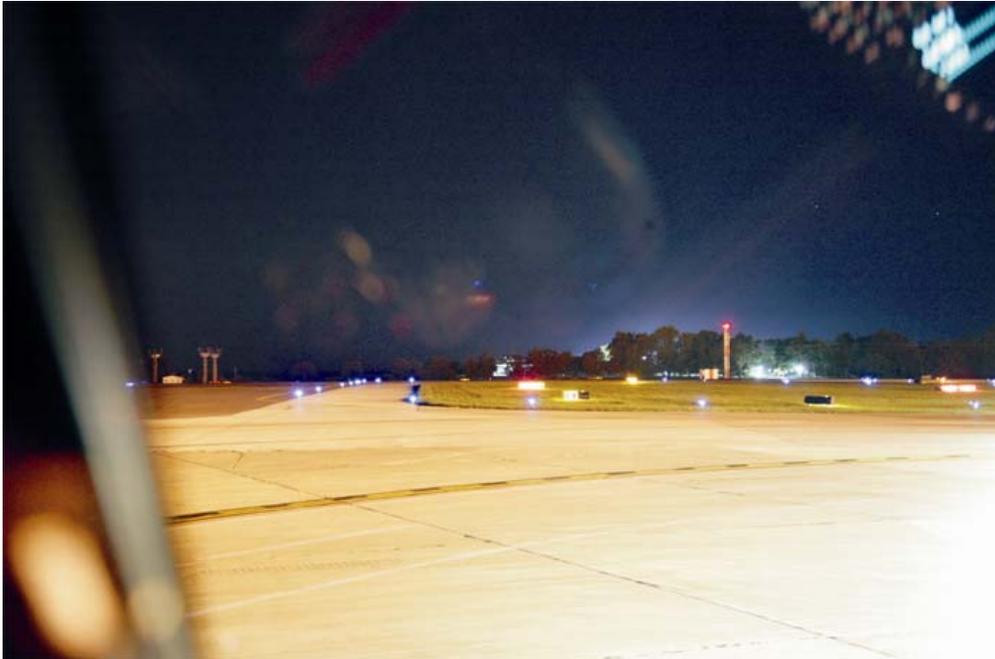
**Photo 3: View of Taxiway "C" from Ramp**

After pushback and prior to aircraft movement under its own power, the aircraft’s heading was approximately 48 degrees while stationary on the ramp. Due to the lack of sufficient data available to the investigation, the exact aircraft geographical starting point on the ramp is undeterminable. However, based on the normal parking spot for Comair aircraft, ramp interviews and some of the FDR information, reasonable assumptions can be made. It appears that after pushback the aircraft was somewhere on the ramp east of taxiway “A” and abeam taxiway “C”. From this approximate location, the view outside the flight deck windows would be vastly different for each crew member. The captain who is seated on the left side of the aircraft would be provided a much better view of the airport’s taxiway as compared to the first officer. As detailed in the visual study performed after the accident, the captain would have been able to look out his left window and look west down taxiway “C” in addition to seeing several runway 4/22 signs and one runway 8/26 sign. Photo 3 shows this view.

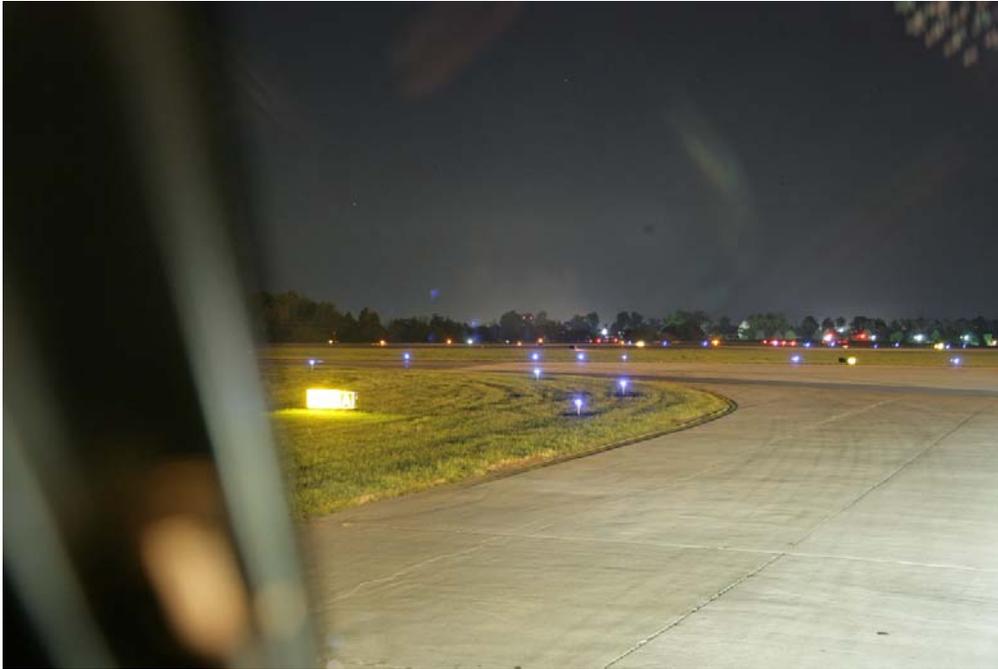
**Photo 4: Taxiway "A" Approaching "A6"**

This segment of the flight as it curves after intercepting taxiway “A” and continues along taxiway “A” until the final left turn onto the straight portion of taxiway “A” prior to runway 26. This represents a significant segment of the taxi event because this is where the crew has the potential to recognize the mismatch between signage and the Jeppesen chart. There are three considerations related to human performance in this segment; signage, airport charts and the crew’s workload. Photo 4 shows the view as the aircraft approaches the “A6” intersection. The Jeppesen chart shows this as “A4”.

As they approach taxiway "A6" this marks the first known point where there was a specific visual threat to the crew's situational awareness. This was probably the first point where the captain's situational awareness becomes challenged. This point of confusion combined with his original less than detailed mental visual image of the airport layout makes it reasonable to suggest that this is where the captain's altered situational awareness becomes significant. Any previous recent night exposure he had to the airport layout was over a month ago and would not be helpful in resolving this conflict. This crew, like all instrument rated pilots, are quite familiar with the Jeppesen instrument charts and overall general airport design and layout. They understand as a matter of practice taxiway intersections are numbered sequentially from one end of a runway to the other, i.e. A1, A2, A3, etc. See Figure 6.

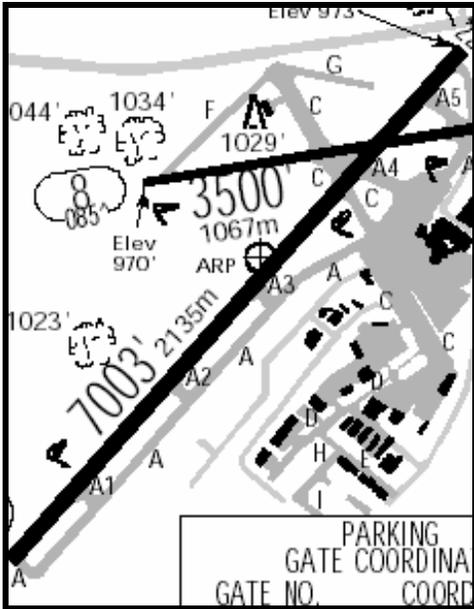
**Figure 6: Jeppesen 10-9 Airport Diagram (current at time of accident)**

When the captain saw the “A6” sign, this could have been interpreted as placing him north of runway 26 in the area of “A5” as shown on his chart. Additionally, after seeing the “A6” sign and not understanding its geographical relevance on the Jeppesen chart, he would naturally seek another data point in an attempt to clarify his confusion and support his current local rationality. The close proximity of the runway 4/22 and 8/26 sign behind the “A6” sign may have provided this data point. It is conceivable that these two signs suggested that the runway is now behind them and they are now approaching the runway 22 threshold. The crew’s Jeppesen chart shows that after you cross runway 26 there are two paths to runway 22; taxiway “A5” and taxiway “A”. Further supporting this idea could be how the first officer’s taxi briefing explained how they would get there; *“let’s take it out and um, take uuuh, alpha, two two’s a short taxi”*<sup>18</sup>. From the captain’s perspective, that is what they were doing, taking “A” to 22. They did not know that the section north of runway 26 was closed so they had no reason to believe that they would not use it to taxi (they never received the local NOTAM via ATIS, the flight release or ATC). The final left turn on “A” approaching 26 is very similar in distance and turn angle as the turn just past runway 26 on “A” to runway 22 (the closed portion). If the captain did have a vague recollection of how the taxiway is designed past runway 26, this section and its design is similar enough to support this idea.

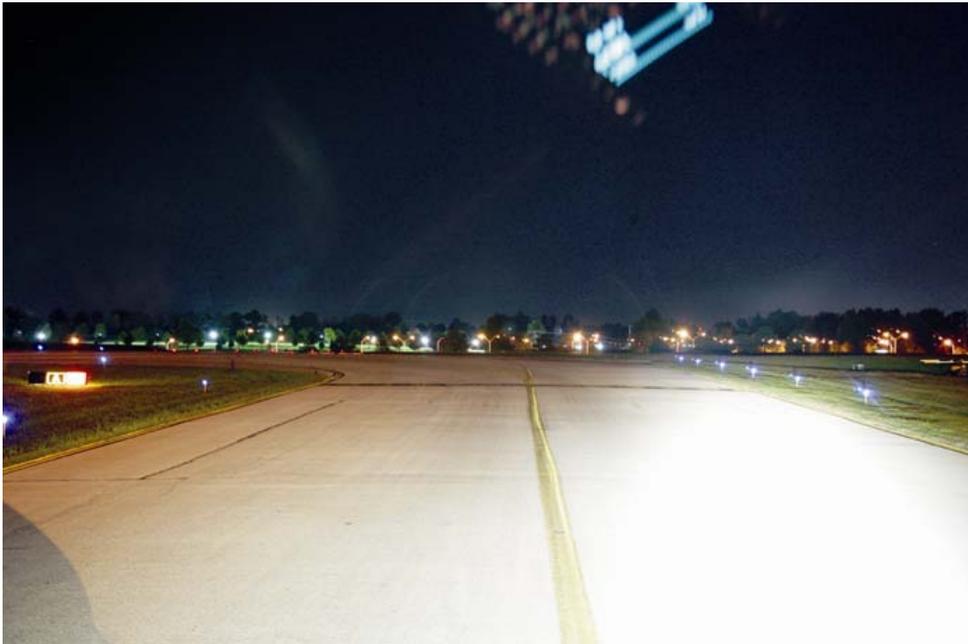
**Photo 5: Taxiway "A" Approaching Runway 26**

taxiway "A" to holding short at runway 26 at 06:04:36. Photo 5 shows the view in front of the aircraft as it makes its final turn onto this segment.

At this point of the taxi event, both crew members situational awareness as compared to reality probably differs from each other for different reasons. Notably, it is wrong in both cases. This will be further explored in the next flight segment. Confirmation bias and plan continuation now play an integral role in why this series of errors and misperceptions was not trapped at this point in time. Three threats are identified to exist during this flight segment and by their very nature, it is reasonable to assume that the crew was not consciously aware of any of them (See Table 7). As a result, none of these were recognized, discussed or managed to any degree. All three will play a significant role in the danger to this flight. With sufficient layers of protection in a safe system, any one of these threats by themselves would not be catastrophic. However, the addition of these threats with the existing threats and errors already discussed made this situation extremely dangerous.

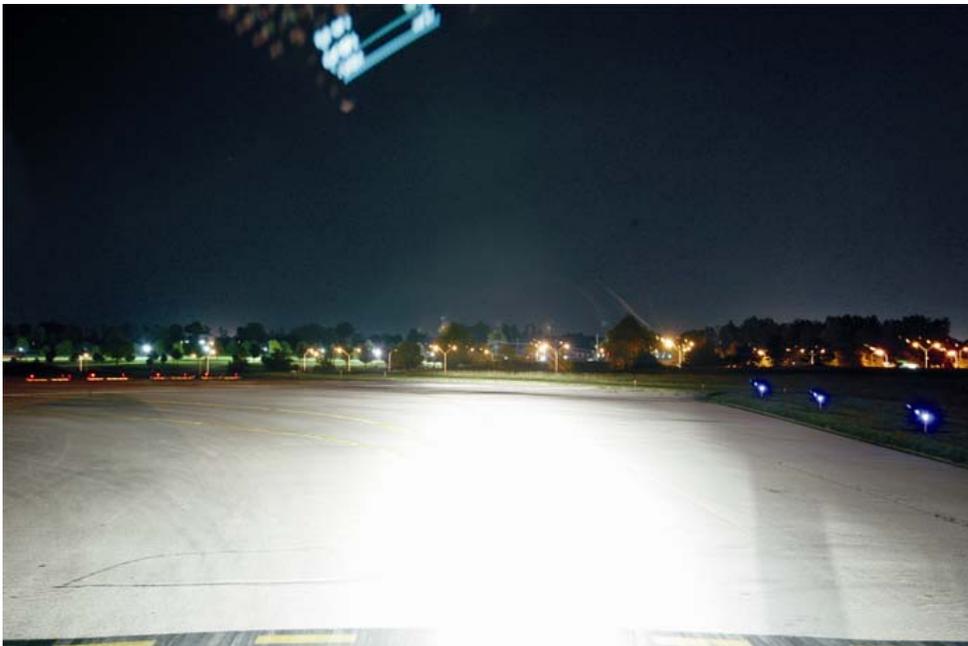
**Photo 6: Hold Short of Runway 26 on Taxiway "A"**

The first officer is again heads down reading the rest of the before takeoff checklist and announces that he is going to the back (euphemism for using the number two radio tuning unit to select the PA system) to make the passenger announcement. The captain at this time and with the aircraft still in motion agrees and takes on the additional cognitive task of monitoring the number one radio for ATC transmissions. This reallocation of duties is a normal function for the captain when the first officer makes his required passenger briefing advising the flight attendant to prepare for takeoff. One second later, four ATC/other aircraft transmissions take place as the captain brings the aircraft to a complete stop at the hold short line for runway 26. Photo 6 below shows this location.

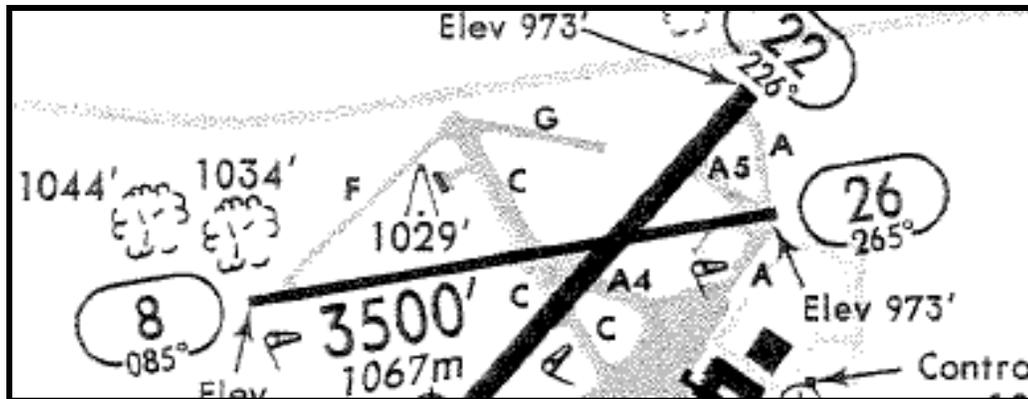
**Figure 7: Jeppesen 10-9 Airport Diagram (current at time of accident)**

An additional visual clue that might have falsely led the crew to believe their location was correct and support their current belief structure was the barricades that they did not expect to see across runway 26. It would be easy to understand how this could have been misconstrued for the closed section (non-pavement) of taxiway golf on the opposite side of runway 22 across from "A5". This would only further support any situational awareness disconnect already in place and feed into their conformational bias that they were in the correct location. This supported the idea that they had in fact taxied to the end of taxiway "A" at runway 22. As the barricades were not mentioned on the flight release or the ATIS, this would have been an unexpected visual clue. Since the chart shows the pavement non-existent, it would make sense that they would have not expected to receive a NOTAM or hear about this on the ATIS. This would only continue to support their local rationality regarding their correct location. See Figure 7.

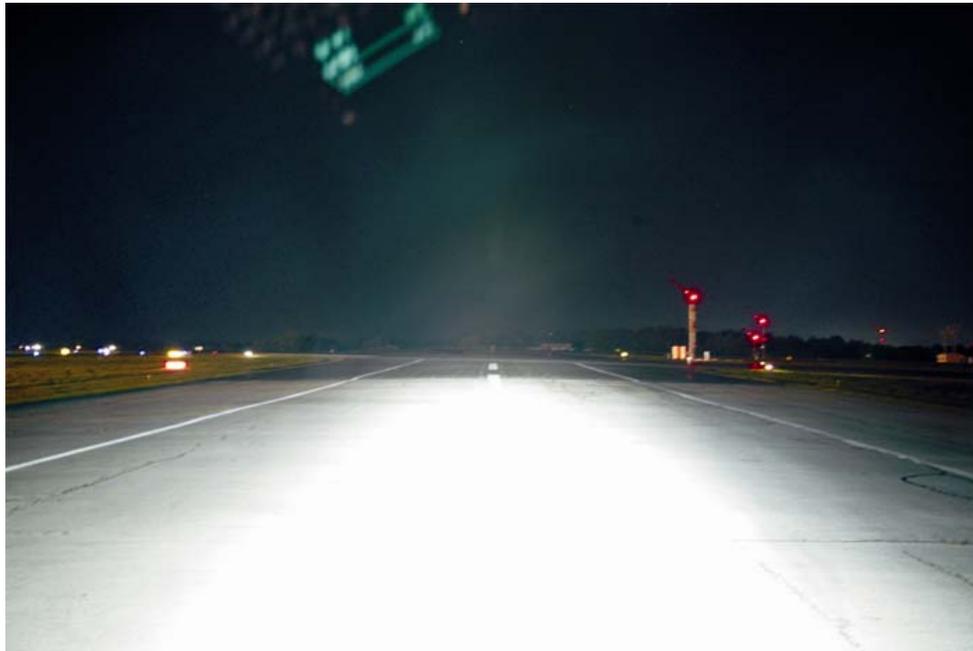
**Photo 7: View down Runway 26 From Beginning of Takeoff Roll**

In Table 11 above, seven of the eight items are essentially self explanatory. However, item two should be further explored. There were three white runway lights combined with a taxiway sign down field that gave the illusion of a partial string of runway lights. Photo 7 below shows these lights.

On the right side of runway 26 at the intersection of runway 22, there were two runway lights represented in a linear fashion and at a similar angle as to appear parallel to runway 26. On the left side was a single runway 22 light in the southeast corner of the intersection. This gave the opposite side corresponding illusion of a runway 26 runway edge light. It is also obvious that there is another runway up ahead which would not have been a surprise since it is reasonable to assume that both crew

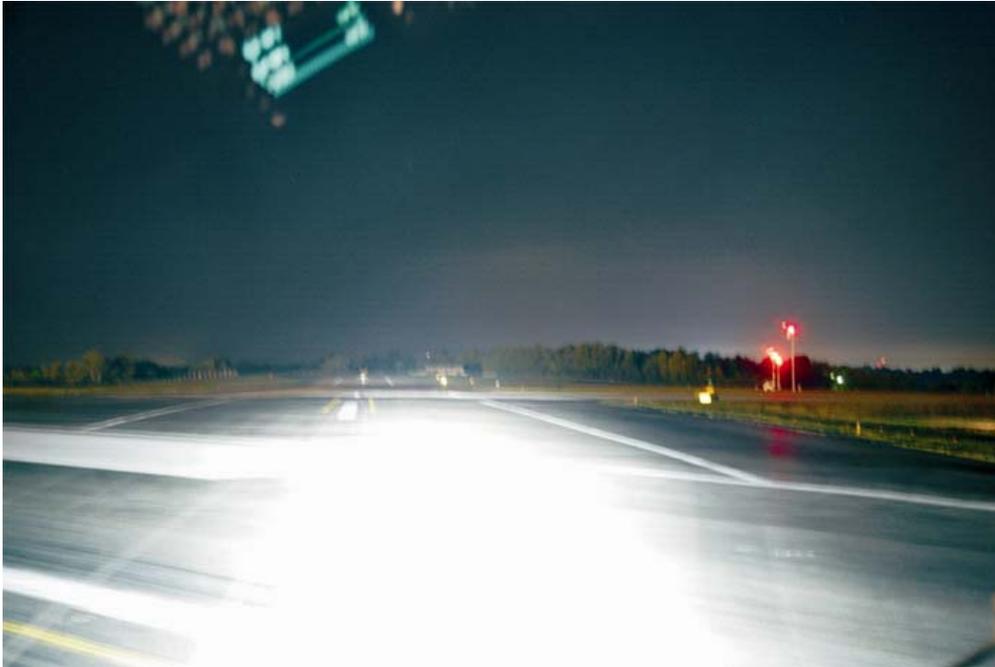
**Photo 8: View Down Runway 26 from Runway 22 Intersection**

Now, as they are rapidly approaching the intersection of the runway and closer to the crest, more of the runway is visible. In reviewing the table above, they have now lost several of the similar visual cues that might have helped convince them that they were in fact on the correct runway. One of the most compelling is the illusion of partial runway lights. It is important to note that approaching the intersection of the two runways, this illusion disappears and we believe that this change elicits the first officer's comment about things looking "*weird*" without lights. See Photo 8.

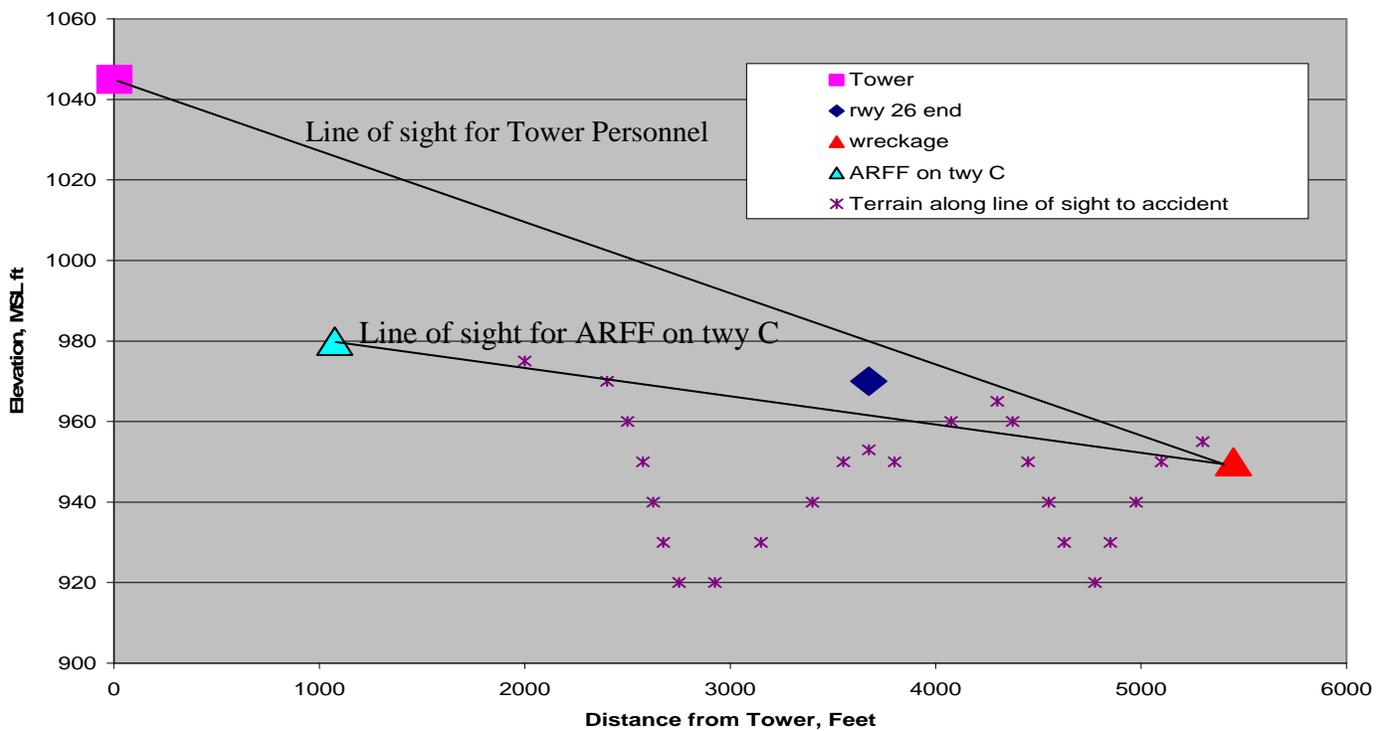
**Figure 9: Line of Sight - Tower and Firehouse to Accident Location**

Figure 9 shows the estimated line of sight for the controller in the control tower, with the tower floor at an elevation of 1,045' to the accident site, and the view from an ARFF vehicle on taxiway "C" coming out of the fire house. It is apparent that neither point would have a completely unobstructed view of the accident scene. However, it appears that the controller would have had a more direct line of sight.

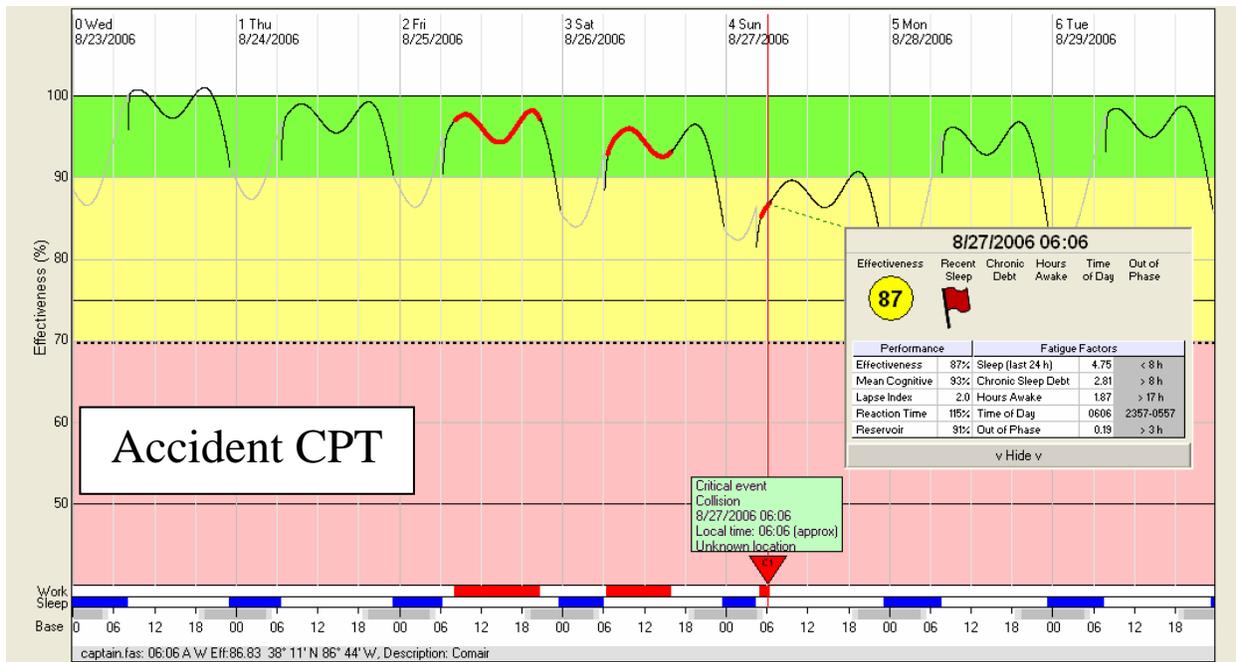
**Figure 8 - Performance prediction for accident CPT based on estimated sleep/wake schedule and circadian phase using the SAFTE/FAST model (courtesy of S.R. Hursh)**

Of the available mathematical models using sleep wake history and estimated circadian phase to predict performance, the Sleep, Activity, Fatigue, and Task Effectiveness Model / Fatigue Avoidance Scheduling Tool (SAFTE™/ FAST™) appears to be one of the better validated ones (Van Dongen, 2004; Hursh et al., 2004a; 2004b; 2006). Using SAFTE/FAST, we obtained performance predictions based on the 96-hour estimated sleep/wake history and circadian phase for the 30 minutes preceding the accident for the accident CPT, FO, and ATC. It is worth noting that neither SAFTE/FAST nor other extant commercially available models takes into account time on task effects. The model yielded numerical predictions of performance for the accident CPT, FO, and ATC. The predictions for each are depicted graphically in Figures 8, 9, and 10. The SAFTE/FAST model overlays green, yellow, and red bands across its performance predictions to indicate safe, questionable, and unsafe levels of performance. Blue bars at the bottom of each plot indicate sleep periods, red bars indicate on duty periods. As can be seen from the figure, the accident CPT, FO, and ATC were all in the yellow (questionable) zone of performance at the time of the accident. The accident CPT and FO were in the upper portion of the yellow (questionable) performance band and the ATC was in the lower part of the yellow (questionable) performance band. The ATC was almost in the red performance band. Thus, using a validated mathematical model (SAFTE/FAST) predicting performance, we found that for the accident CPT, FO, and ATC we would expect their performance to be mildly to moderately impaired by sleep loss and adverse circadian phase at the time of the accident. For reference, an effectiveness level of 70% is equivalent of a blood alcohol level of 0.08 g/100mL or 21 hours of continuous wakefulness (Hursh, et al., 2006).
