Submission of the
Air Line Pilots Association, International
to the
National Transportation Safety Board
Regarding the Accident Involving

Colgan 3407
DHC-8-Q400
DCA09MA027
Clarence Center, NY
February 12, 2009

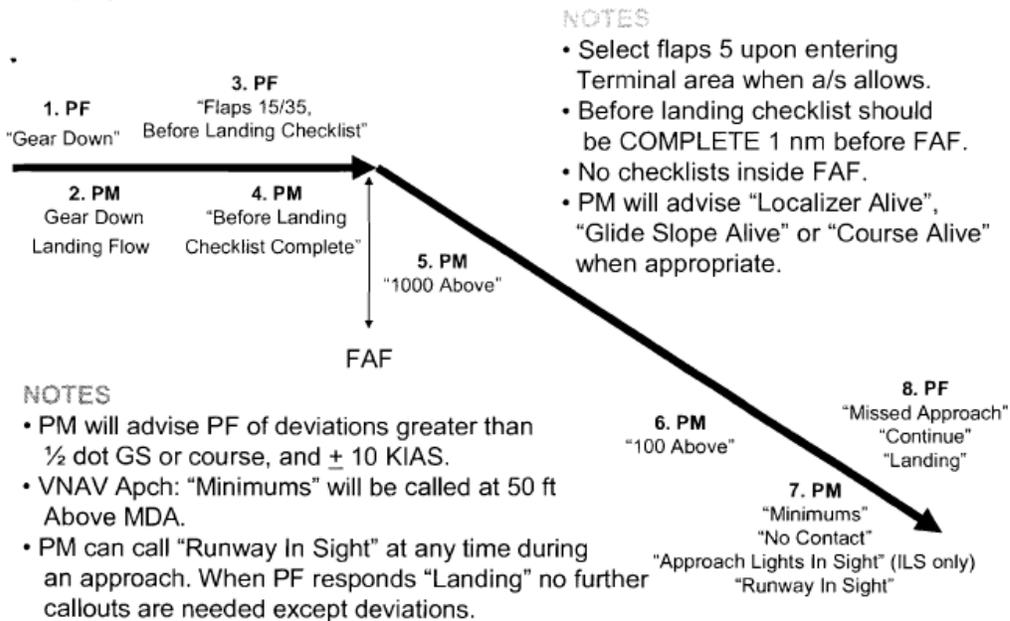
Figure 2- Colgan Q400 CFM (Section 10 Page 2)

In addition to the landing speeds V_{ref} and V_{ga} , the crews were also supplied V_{fri} and V_{cl} speeds. Due to the design of the Q400, there is no method to bug these important numbers on the PFD during landing. These numbers would be required in the event of a missed approach, go around, or stall. Some

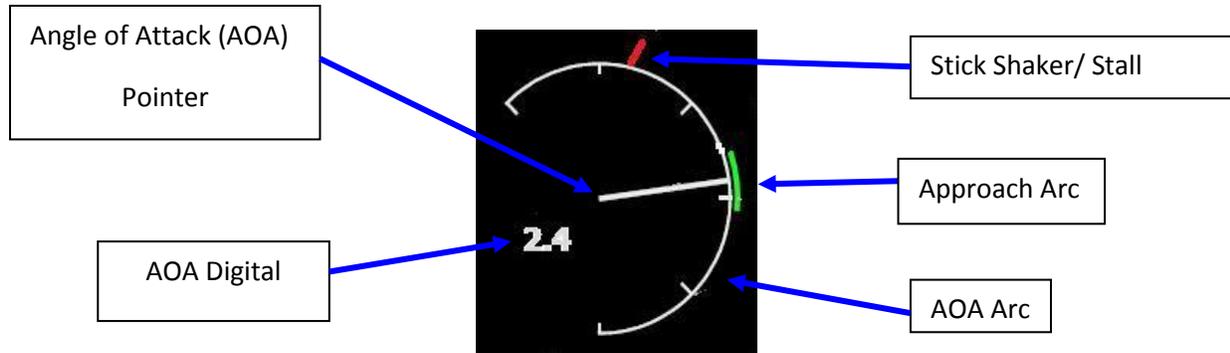
Figure 4- Angle of Attack Indicator

Other useful cues that can aid the pilot in avoiding a stall exist, however they are not installed on the Q400. One is an **angle of attack indicator**. As noted above, the aircraft is equipped to measure angle of attack and uses that information for some displays. However the "raw data" is not displayed to the flight crew. An angle of attack indicator can be an extremely useful tool to a crew, given proper training. It provides basic, unfiltered information directly related to the aerodynamic capability of the aircraft at that moment under all conditions. It displays actual angle of attack information to the pilot on the PFD or a separate instrument. This lets the pilot know the actual angle of attack and can alert the pilot to the aircraft's proximity to a stall. This can be especially useful when an aircraft is maneuvering, flying slow,

or is changing flap configuration. It can also alert a pilot that his plane’s weight has been incorrectly calculated resulting in incorrect approach speed calculations.

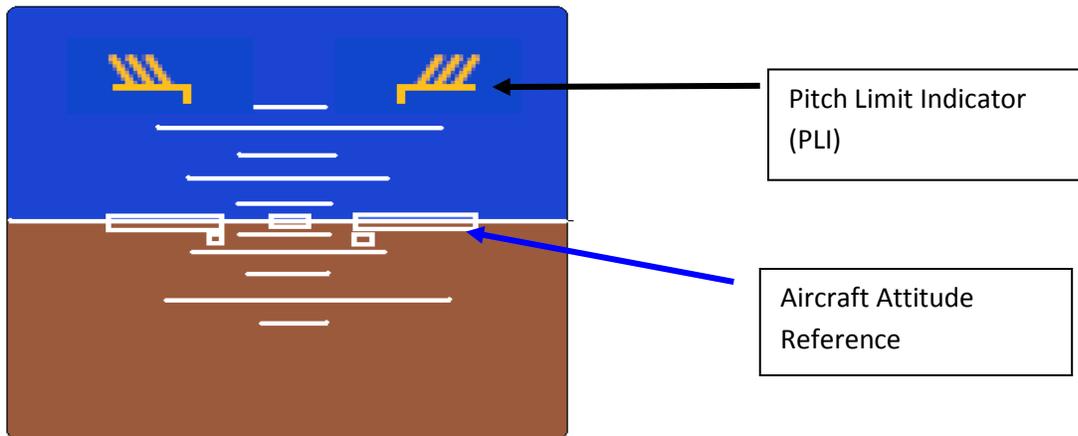
Figure 5- Pitch Limit Indicator

Pitch Limit Indicators (PLI) display the aircraft pitch attitude that will activate the stick shaker. The PLI is a moving indication on the artificial horizon display of the PFD. These pointers, or “eyebrows,” display at high angles of attack and low airspeed above the pitch indicator of the airplane. These pointers move closer to the pitch display as the aircraft increases its angle of attack. They will touch the pitch cue at the same time the stick shaker activates. This gives the pilot direct feedback on the relationship of the aircraft’s pitch to stall and advance indication of pending stick shaker activation. The most important benefit of a PLI is that it gives the pilot immediate direction during a stall on where to pitch the aircraft’s nose to break or exit the stall.

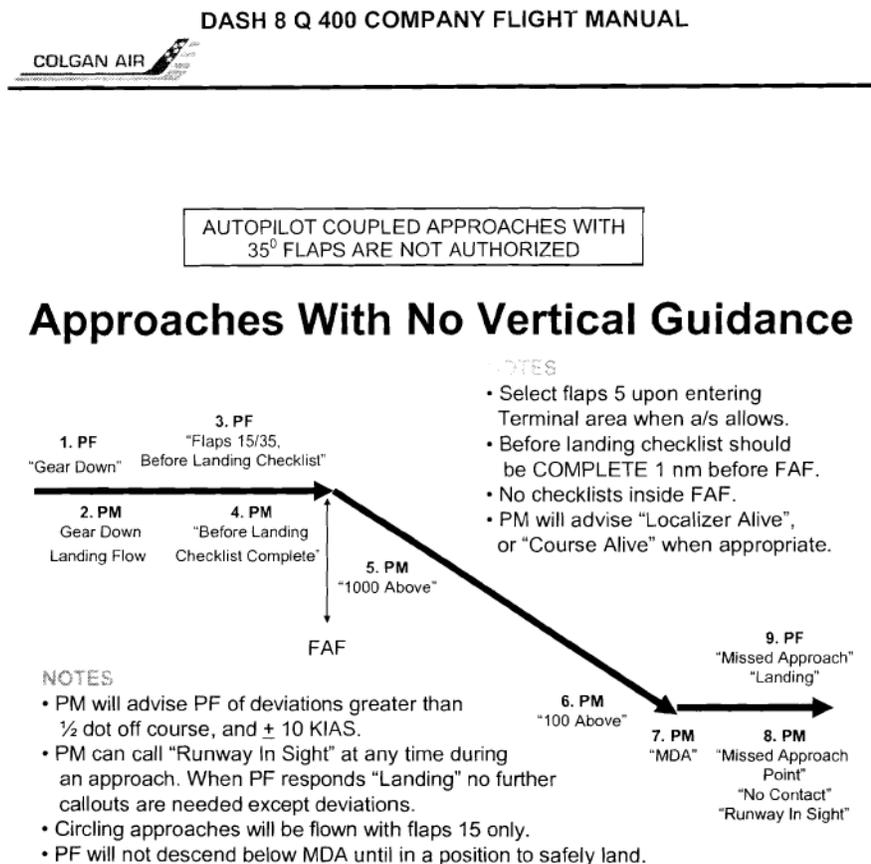
Figure 12- Colgan Q400 CFM (Section 10 Page 3)

The profiles do not provide basic milestones for crews on the approach and are very vague based on the depiction as to when key sequences (Gear and Flap Extension) should occur. This ambiguity poses the hazard of unstabilized approaches and leads to non-standard operations. To evaluate industry standardization on providing crews information for various profiles, ALPA examined several exemplar manuals including a Boeing 777, CRJ-200, and DHC-8-200. Each of these manuals provide both a pictorial and expanded textual depictions of how a crew should fly each maneuver including at what point on the approach the gear should be extended, as well as flaps. In addition to this lack of guidance the CFM also fails to provide crew members with target or minimum airspeeds to fly based on the respective flap setting. The only airspeed guidance provided is the V_{ref} or $V_{ref(ICE)}$. Additionally, Colgan provides no guidance in determining V_{app} speeds even though the approach airspeeds to be flown in icing conditions from **Figure 10** references a V_{app} .

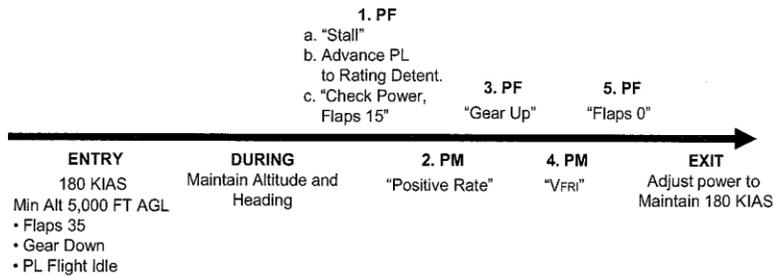
Figure 13- Colgan Q400 CFM (Section 10 Page 9)

These depictions were inadequate in several ways. The title of the depictions was not prefaced by the term “Approach to” (e.g. “Landing Stall” **Figure 13**). This could have implied it was a recovery procedure for a stall itself. The actual recovery cue required by the PTS is to recover at the first indication of an impending stall (buffeting or stick shaker). The Colgan profiles provided no such recovery cue. Colgan only instructed its pilots to “maintain altitude and heading” and demonstrated this by using a straight-line example for its profile (**Figure 13**). As was previously discussed in 2.3.3, there were only a few notes associated with the “approach to stall” depiction, there were no expanded text to tell pilots what additional procedures must be accomplished. An example of this would be for the Pilot Flying (PF), the only guidance was “Advance PL to Rating Detent”, “Gear Up” and “Flaps 0,” there were no additional descriptions on how to recover. There is no mention or discussion of an actual stall event. A stall results from exceeding the critical angle of attack and to fully recover from a stall the angle of attack must be reduced. Another issue with the Colgan stall recovery procedure pertains to the Pilot Monitoring responsibilities. Although the Pilot Flying states “check power” during the recovery, the recovery profile did not define what the Pilot Monitoring should be “checking” or doing with the Power Levers. The recovery profile does not require the Pilot Monitoring to verbalize the power levers have reached the desired power setting. The recovery procedure does not require the Pilot Monitoring to advise the Pilot Flying the state of the aircraft and status of the stall recovery by making call outs regarding pitch attitude, airspeed trend, and altitude. The recovery procedure does not give pilots pitch

recommendations that may be required during an actual stall recovery. During the Public Hearing, Q400 Chief Simulator Instructor, Paul Pryor stated over and above what is on the Colgan stall profile, Colgan does not provide specific training to the Pilot Monitoring during a stall event.²⁸
