**Submission of the
Air Line Pilots Association, International
to the
National Transportation Safety Board
Regarding the Accident Involving**

Delta Air Lines 1086

MD-88

DCA15FA085

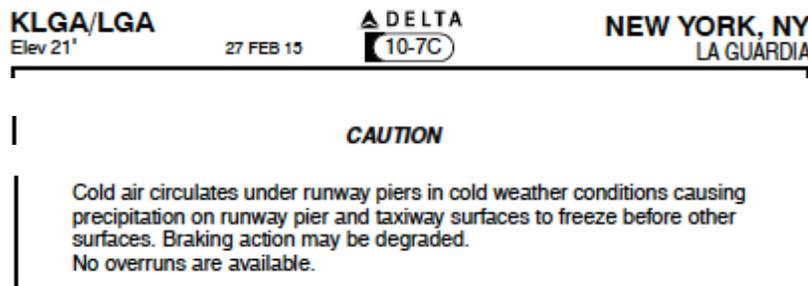
Figure 2: Delta 10-7 Page, Caution for Landings on LGA Pier

Runway 13 at LGA is 7,003 feet long. The first 1,000 feet is constructed of a concrete pier. Cold air circulates under the pier causing the surfaces on the pier to freeze before the surfaces of the rest of the airport in cold weather conditions.

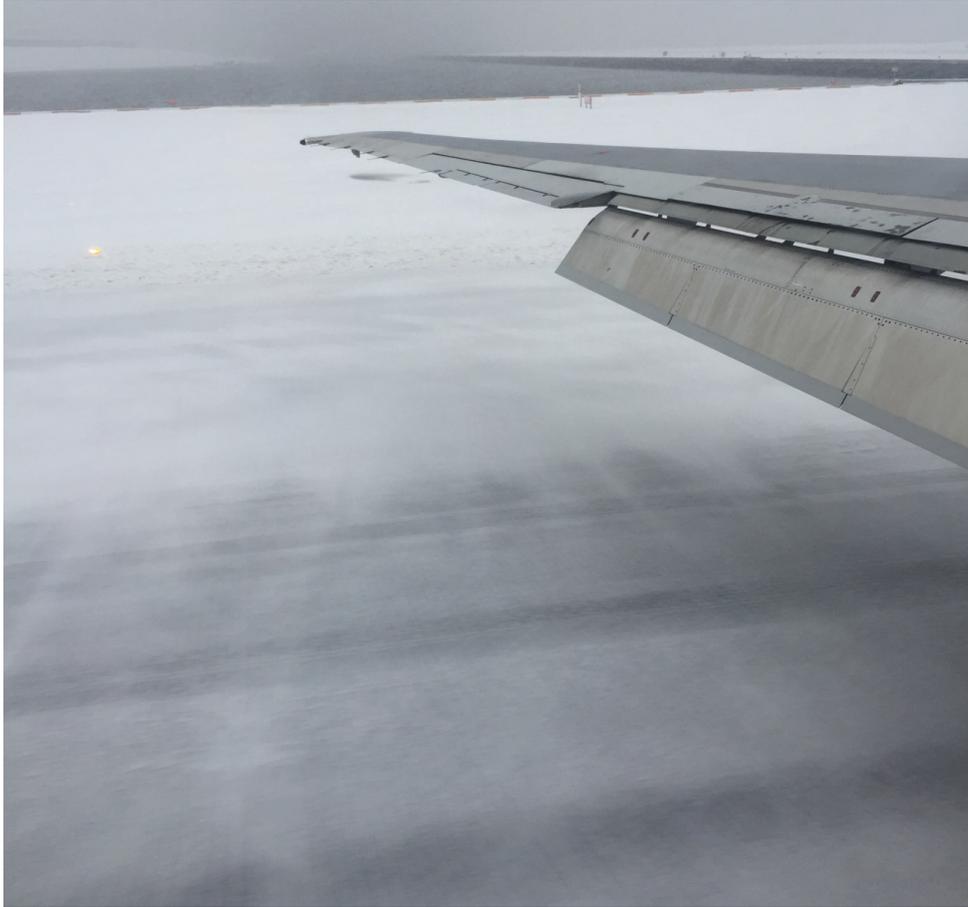
Braking action is a function of downforce on the braking wheels (main) and the surface friction. The failure of the spoilers to auto deploy was most likely the failure of the main wheels to get sufficient traction on the icy surface of the pier section. The subsequent delay in spoiler activation and the further delay in ground spoiler movement would have caused a period after touchdown of reduced downforce. During this time, speedbrake handle movement to the deployed position by the FO would have caused maximum auto brake activation after a 1 second delay. If wheels were subject to brake pressure before adequate rotation speed, they would lock quickly. Locked wheels would not provide useful braking or cornering force. The wheels would stay locked unless rotation and antiskid were regained. In the case of all four wheels being locked, this would require a complete release of the brakes and then reapplication. During testimony for the American Airlines (AA) Flight 1420 accident public hearing, a NASA engineer stated that abnormal antiskid operation would be expected with low to no wheel spin-up accelerations on a low to no traction runway surface and delayed spoiler deployment.

Figure 5: Passenger Photograph out of the left side window at the 500 foot runway marker. Note retracted spoiler panels.

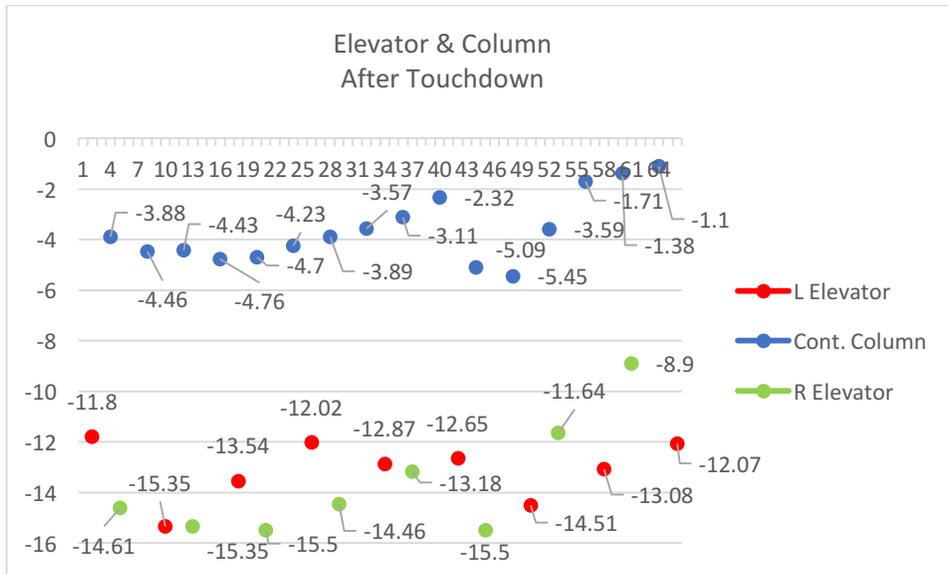
Figure 6: Elevator and Control-Column Position After Nose-Gear Touchdown

The FDR recorded the elevators at a flight position around 2 degrees nose down (-2) moving to a position around -15 degrees after touchdown. At the same time, the control column moved from around 10 degrees nose up to around 5 degrees or less nose down. The maximum parameter for elevator travel is 15 degrees (displayed as minus) trailing edge down, and for control column is 10 degrees (displayed as minus) forward.

This placed the elevators at or near the maximum full-down position for most of the ground roll from ground shift (WOW) leading through loss of heading control. The elevators reached 15 degrees nose down one second before the heading began to move left and varied between 15 and 12 degrees.

The elevators do respond and follow direction of control-column movement during this period. But their movement appears out of proportion to displacement of control-column movement toward nose down. For example, the control column remained within 1 degree of 4 degrees of nose-down column position, about half of its forward travel, for most of the first 10 seconds. However, the elevators remained between 11 and 15 degrees; two thirds to full travel. The left elevator showed greater travel than the right. The left reverse EPR was also higher than the right during this period. The effect seems somewhat diminished when reversers stowed.

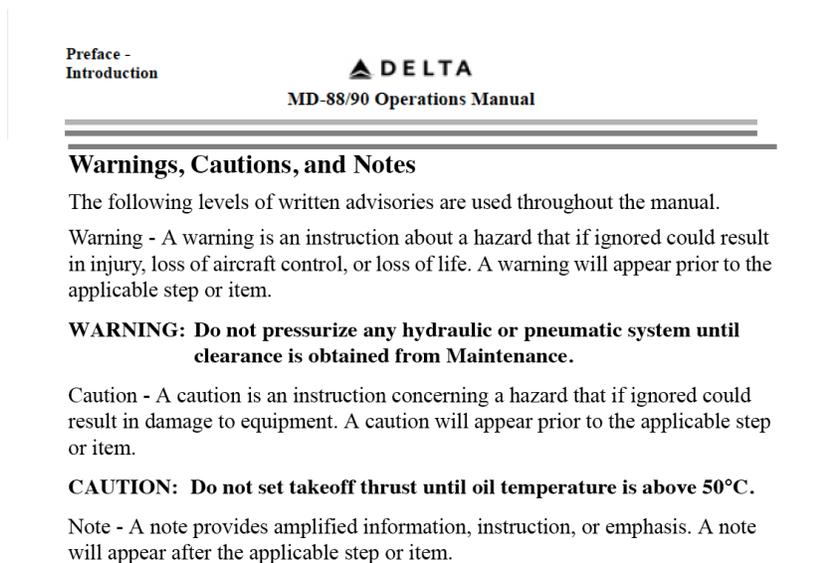
Figure 7: MD-88/90 Operations Manual Vol 1—Page P1.2.4, definitions

The AOM referenced caution and Warning statements to emphasize potential hazardous conditions. Several statements labeled as “caution” better describe instructions that meet the definition as warnings in accordance with the Delta Operations Manual Vol 1–P1.2.4. This could affect the pilot’s interpretation of the threat noted in these statements.

In the following example, the “CAUTION” should be a “WARNING” because the potential loss of control can lead to injury or loss of life based on the information from Figure 7 above.

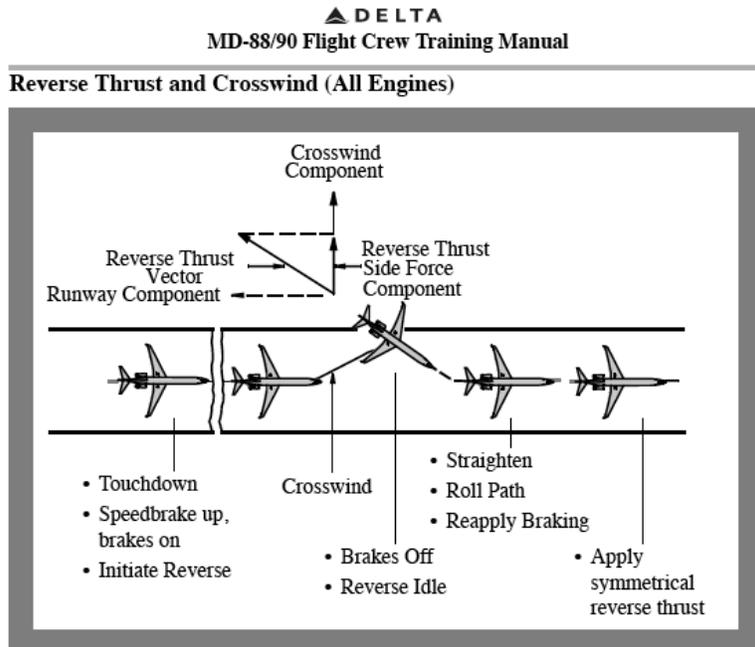
Figure 8: Delta FCTM guidance reverse thrust operations in crosswind conditions

During the accident landing, the aircraft remained near the center of the runway as the heading began to drift left. As the airplane turned, the cockpit approached the left side of the runway. This would be perceived by the pilots as the aircraft drifting toward the upwind side of the runway. This perception would be confusing to the pilots, as guidance in the second bullet, as well as the figure from the FCTM below, would indicate the airplane would drift downwind during reversing on slippery runways.

The FCTM in a section labeled “Reverse Thrust” states: “The PM should monitor engine operating limits and call out any engine operational limits being approached or exceeded, any thrust reverser failure, or any other abnormalities.” Although this addressed engine limits and reverse-thrust abnormalities, it did not specify a callout of excessive EPR settings as addressed in the Boeing FOB.

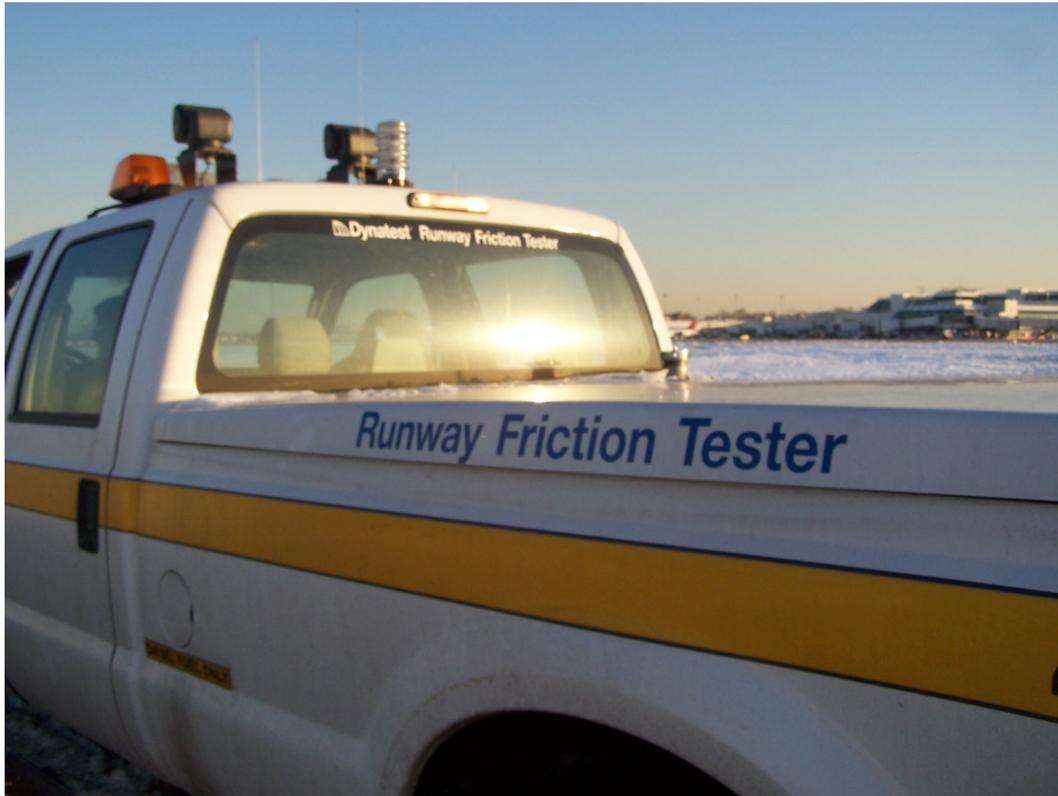
Figure 9: LGA Truck with Runway Friction Tester

During the snow event, LGA Airport did not use continuous friction measuring equipment (CFME) devices, which were purchased and stored at the airport due to nonuse and calibration issues. The use of CFME devices is recommended by the airport to monitor friction trends per AC 150-5300-30C. The airport's operations manager stated that he understood that the CFME could be used as a tool for snow removal trend analysis, but on the day of the accident they were evaluating the runway based on their observations and snowfall rate. This is in contradiction to LGA's Airport Certification Manual (ACM) and training videos,⁵² which stated that LGA utilizes a CFME-type friction tester to conduct friction readings when conditions require trend analysis on a frozen or contaminated surface. The ACM also contained a letter of agreement (LOA)⁵³ with the LGA Air Traffic Control Tower (ATCT) stating that when it becomes apparent that conditions may result in degraded runway surface friction, Airport Operations may conduct friction assessments using whatever techniques the airport duty manager or snow coordinator deem appropriate, to include tactile feel, vehicle braking, and/or use of CFME.⁵⁴ If CFME is used, Airport

Operations will not report Mu values. During the morning leading up to the accident, the runways were only evaluated based on observations of snowfall rates, and no CFME device was used.

The FAA Advisory Circular AC 150-5200-30C is too lax, as it allows a procedure using only braking action reports to qualify as “continuous monitoring” of the runway surface. Other methods are only recommended and not mandated. Use of friction monitoring equipment or decelerometers are only recommended actions for the airport.

In order to provide flight crews with the most current and accurate runway condition reports, it would be good practice to conduct a tactile inspection of the runway condition. This allows the airport operator to distinguish between wet snow or slush and dry snow. No provisions in AC 150-5200-30C require a tactile measurement of snow depths or condition, which allows the airport operator to estimate depths and conditions when issuing NOTAMs; this was admitted by the LGA airport operator as stated in interviews that they just leave “0.25-inch clutter” in every NOTAM issued, unless it gets deeper.
