In accordance with the Board's rules, the Air Line Pilots Association submits the following comments concerning the accident involving Comair Airlines Flight 5054, which occurred on March 19, 2001 near West Palm Beach, Florida.

**SUBMISSION OF THE
AIR LINE PILOTS ASSOCIATION
TO THE
NATIONAL TRANSPORTATION SAFETY BOARD
REGARDING THE ACCIDENT INVOLVING
Comair Flight 5054
OFF WEST PALM BEACH, FLORIDA
ON MARCH 19, 2001**

ALPA Submission on Comair Flight 5054, EMB-120
West Palm Beach, Florida, March 19, 2001

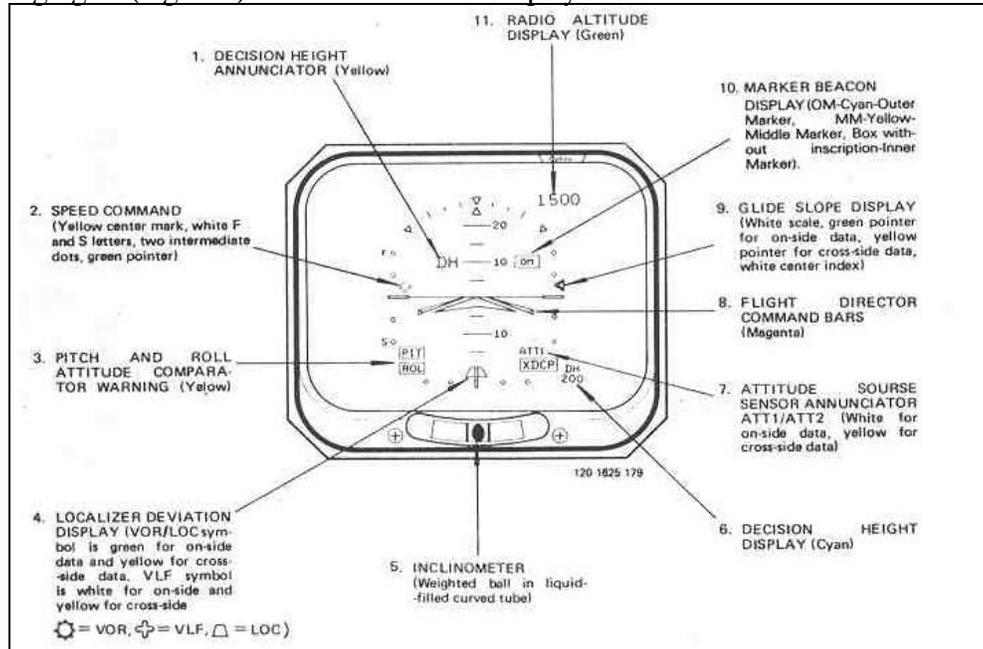
Figure 1

The following figure (Figure 1) shows the elements displayed on the EADI.³

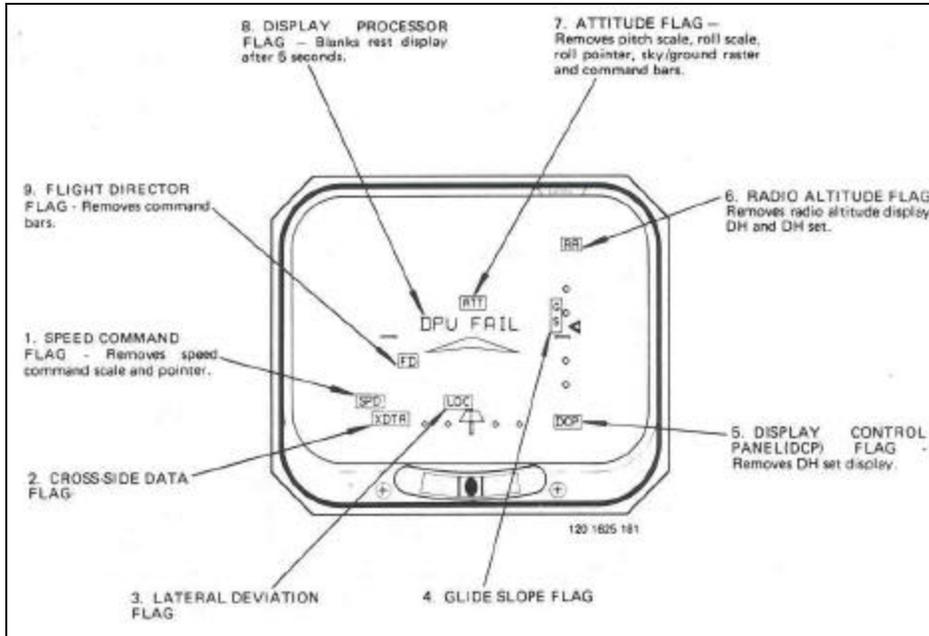
Figure 2

The EADI has several failure/error messages that display on the screen. In postflight interviews of the crew, the crew was not certain of the message that they saw during the roll excursion. The EADI failure messages are displayed in the following format from the Embraer EMB-120 Operations Manual.
