# I. EXECUTIVE SUMMARY

## A. History Of Flight

At 0607 Eastern Daylight Time (EDT) on August 27, 2006, a Canadair RJ (CL65-2B19), N431CA, operated by Comair Airlines (CMR) Flight 5191, crashed on takeoff from Bluegrass Airport, Lexington, Kentucky (LEX). The flight was destined for Atlanta, Georgia. There were 3 crew members and 47 passengers on board. Forty nine of the 50 souls onboard received fatal injuries and one received serious injuries.

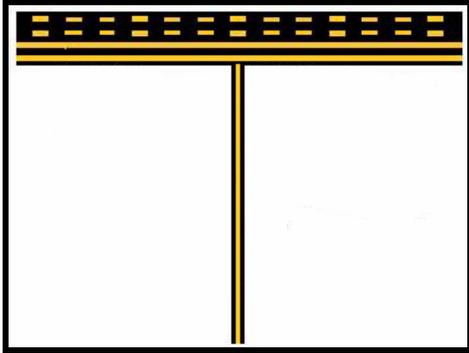
**Figure 3: Standard Hold Short Marking**

Blue Grass Airport. Figure 4 shows the enhanced marking with surface painted holding position signs, we recommend based on the current AC.
