Submission of the
Air Line Pilots Association, International
to the
National Transportation Safety Board
Regarding the Accident Involving

Colgan 3407
DHC-8-Q400
DCA09MA027
Clarence Center, NY
February 12, 2009

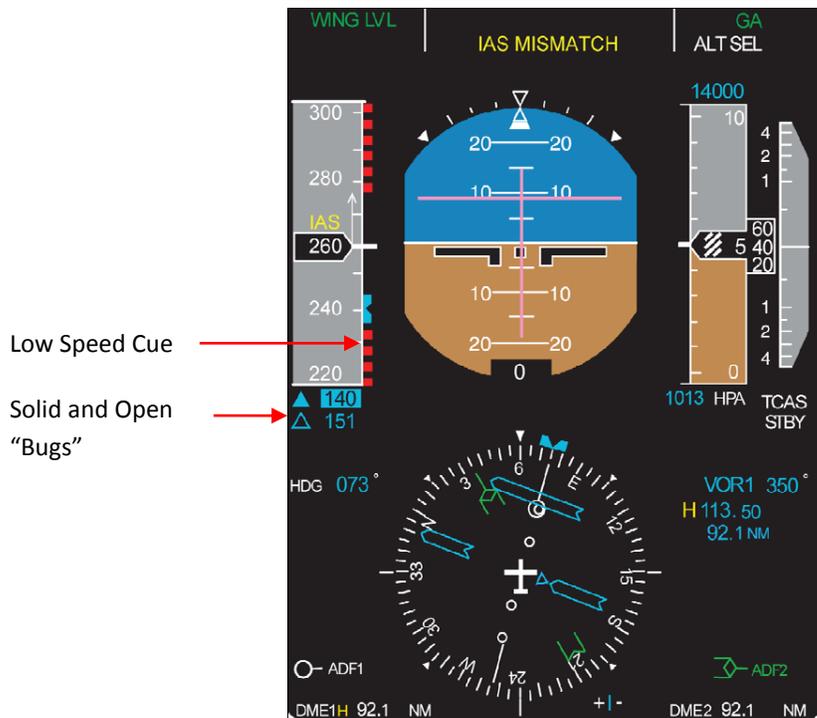
Figure 1- Q400 Primary Flight Display⁶

Bombardier, with the introduction of the Q400 to the Dash 8 series, added a new element to the Stall Protection System (SPS) called the Reference Speeds switch, for use when operating in icing conditions. The Reference Speeds switch is designed to increase the stall margin provided by the Stall Protection System when selected to the INCR position. When this switch is in the INCR position the Stall Protection System uses a lower Angle Of Attack threshold for activation of the stick shaker, effectively providing stall warning at a higher speed under normal flight conditions. This is displayed to the crews by the low speed cue advancing up the airspeed tape on the Primary Flight Display by approximately 15-25 knots, depending on flap position. When the Reference Speeds switch is in the INCR position there is also a white “INCR REF SPEED” message posted on the ED.

If higher “ice” speeds were set, the interim CFM did not state at what point (if ever) a crew could adjust to the lower “clean” landing speeds should the aircraft be free of ice contamination and out of icing conditions. Conversely, the manufacturer’s aircraft flight manual, to which crews had no direct access outside the flight deck, did specify parameters for which crews were required to adjust or readjust speeds. This could lead to crews inappropriately adjusting speeds during the approach and landing phase of flight. Other Q400 operators have shown the use of these “icing” speeds can be done in a very standardized manner. Horizon Air stated in an interview they decided to set bugs in a way that would avoid confusion, especially because of the Reference Speeds switch. Horizon always sets their bugs the same way. They bug the solid bug at $V_{ref-icing}$ and the open bug at $V_{ref-clean}$ (**Figure 1**). There is no switching of speed bugs during the approach and landing phase of flight.⁹

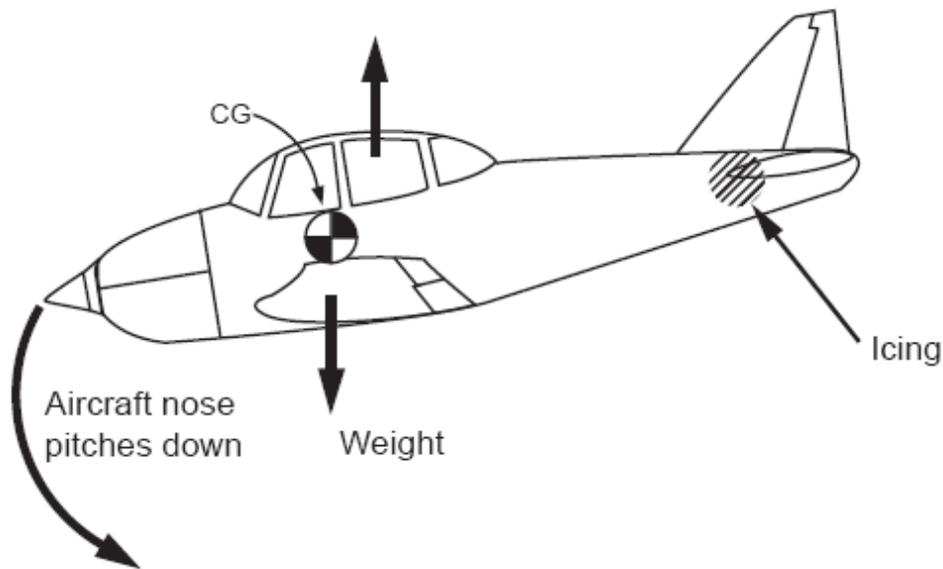
Figure 15- Pitch Over Due To Tailplane Stall (Federal Aviation Administration, 2007)

During the Public Hearing, Mr. Don Stimson stated the FAA's position is that tailplane stall susceptibility is unacceptable as it is considered an unsafe condition.⁴⁸ This illustrates the changes in aircraft certification that have taken place as the result of research generated by the icing induced upset accidents of the past. Mr. Paige, from Bombardier, stated that Bombardier designed the Q400 with tailplane icing in mind and there have been no reports of tailplane stalls.⁴⁹ Improved certification standards have made these events rare, however it is possible for an aircraft to encounter significant icing conditions that exceed the certification standards (Federal Aviation Administration, 2007). It is for this reason, as Mr. Ratvasky suggested during the hearing, that pilots should be trained on the aerodynamic affects of icing *including the particular characteristics of their aircraft* (emphasis added).⁵⁰
